# Arboricultural Survey, Appraisal and Recommendations

10/06/2018

**Report Reference: QUEENDR001**

**Longacre Professional Arboricultural Consultancy**

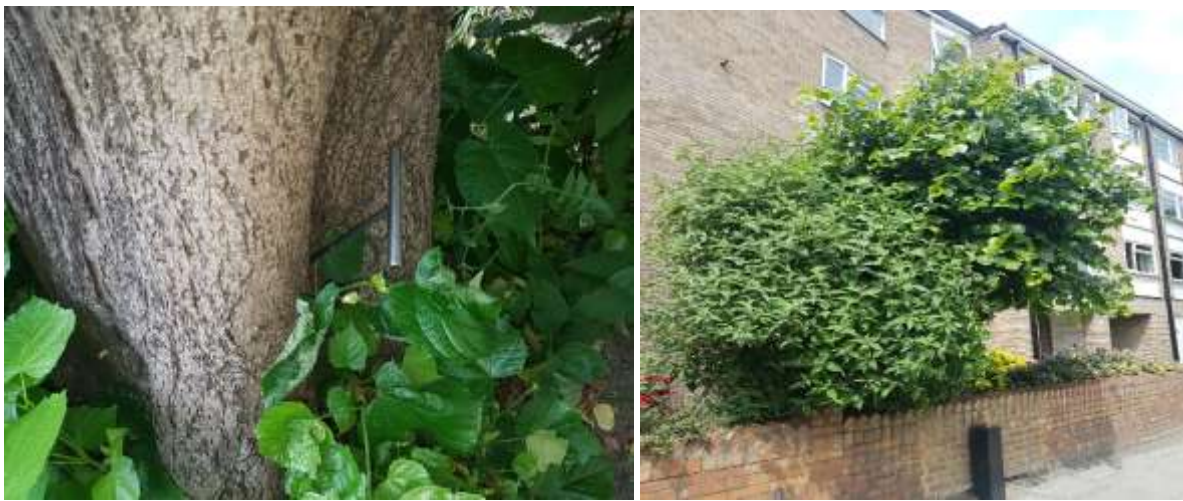
### T6 Details

Crown	Poor / Bad crown development
Stem	Poor / Cavity at 2m
Base	Poor / Root-ball degradation
Root crown	Poor / Limited by adjacent structure
SULE	0-5years

### Comments:

This specimen has a poor structure and is likely to fail if allowed to regenerate to any significant potential. Its proximity to structure and (advised) association to structural damages leave its longevity in question.

T1-T2: No action required
T3-T5: Remove all epicormic growth (do this annually), allow crown to develop for one more year and then re-pollard back to knuckles
T6: Remove due to physiological related issues (SEE Appendix B)
T7: Manage at current dimensions, do not allow to exceed.
PT1-PT2: Notify local authority of potential to become influential on property structure.
Site recommendation – Apply mulch to T1 and T2, consider removal and replacement of T3 to T5 due to general condition of specimens.
