**Longacre Professional Arboricultural Consultancy**

Arboricultural Survey, Recommendations and Cyclical Management Plan

08/09/2018

Report Reference: LYE001

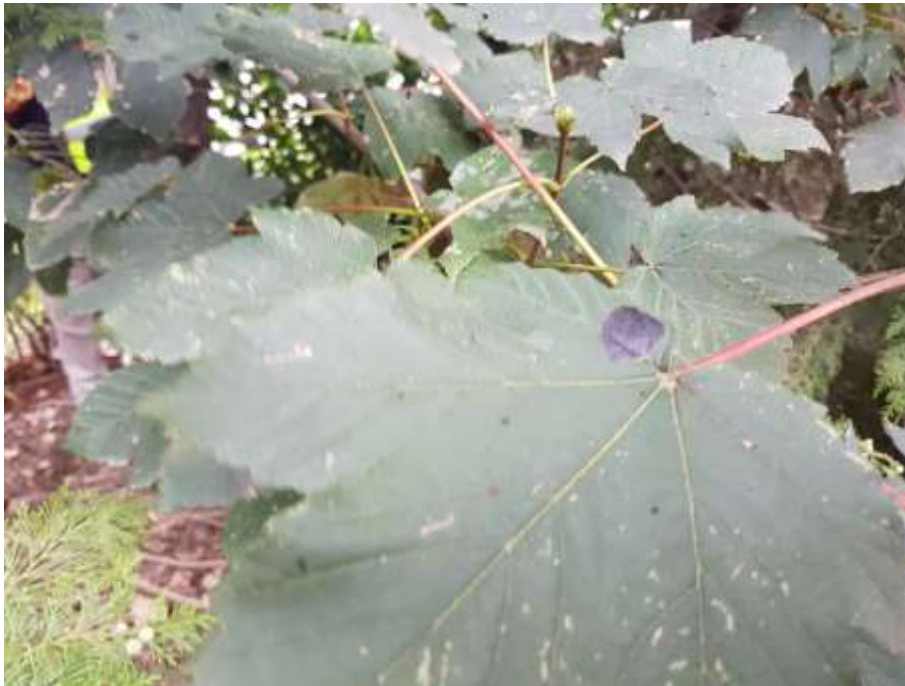
**402/TAG: 4061**

Rhytisma acerinum (sycamore tar spot) emerges in late summer, it has no serious effect on the physiological condition of the infected host but can be an eyesore during the autumn flush.

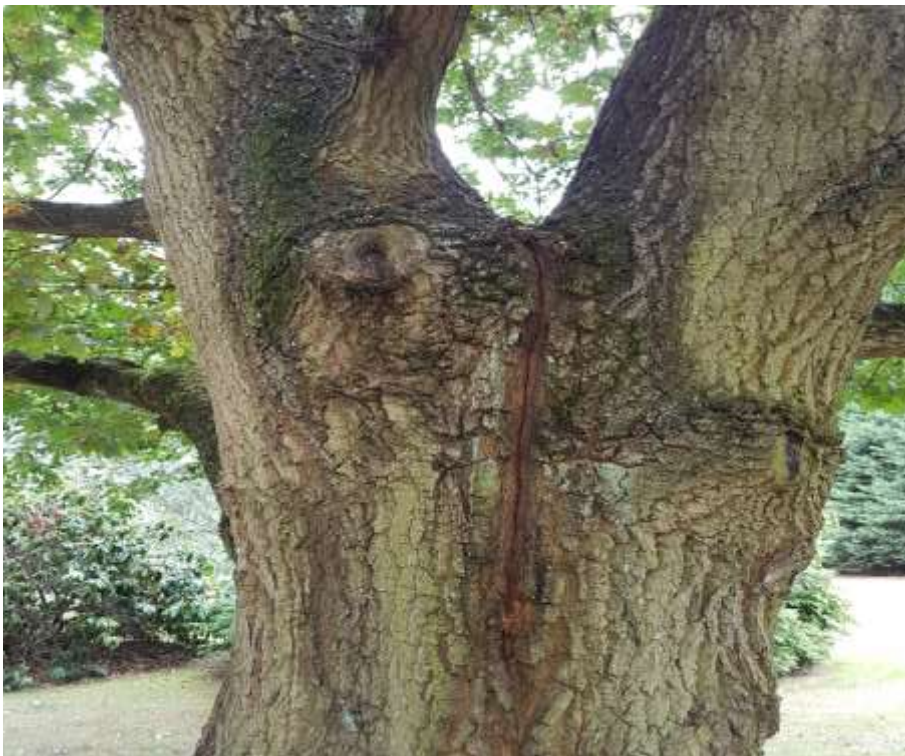
**T390/TAG: 4050**

Where two stem meet and are divided by annual growth there becomes a potential weak spot. This can be managed by the addition of cable bracing to support the crown against itself.

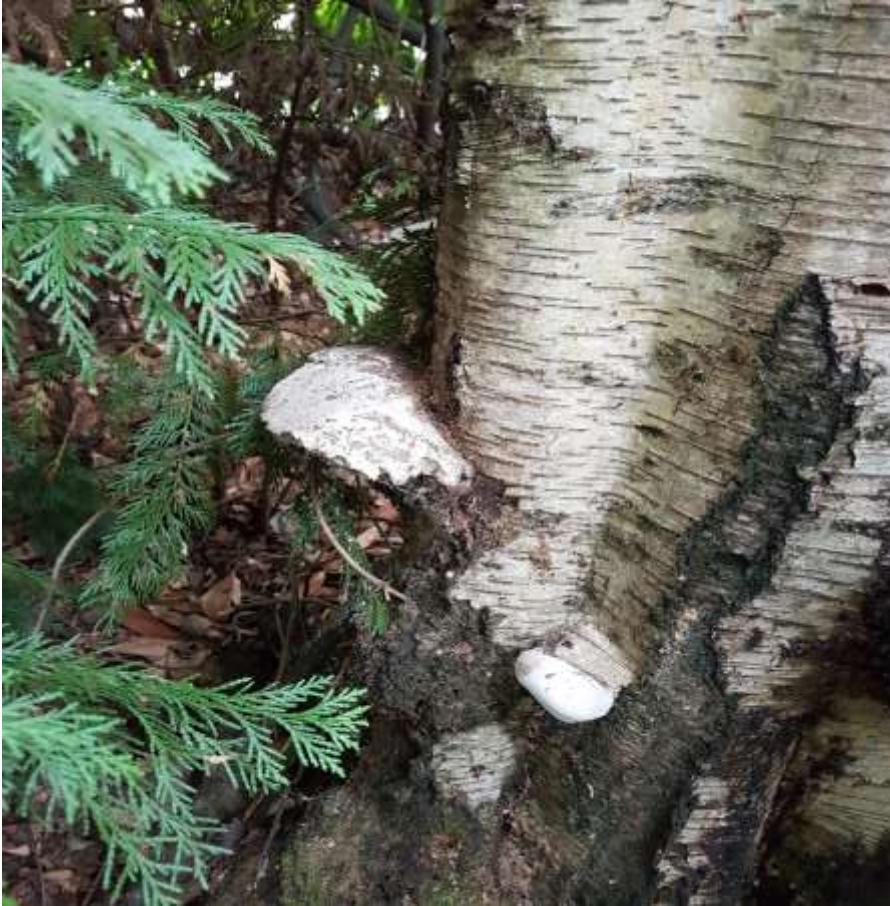
**T402/TAG: 4061**

*Piptoporus betulinus* is a fungal strain that is very fast acting, breaking down the structural stability of the infected Birch. Removal becomes necessary when a public space is within the drop zone of the infected host.

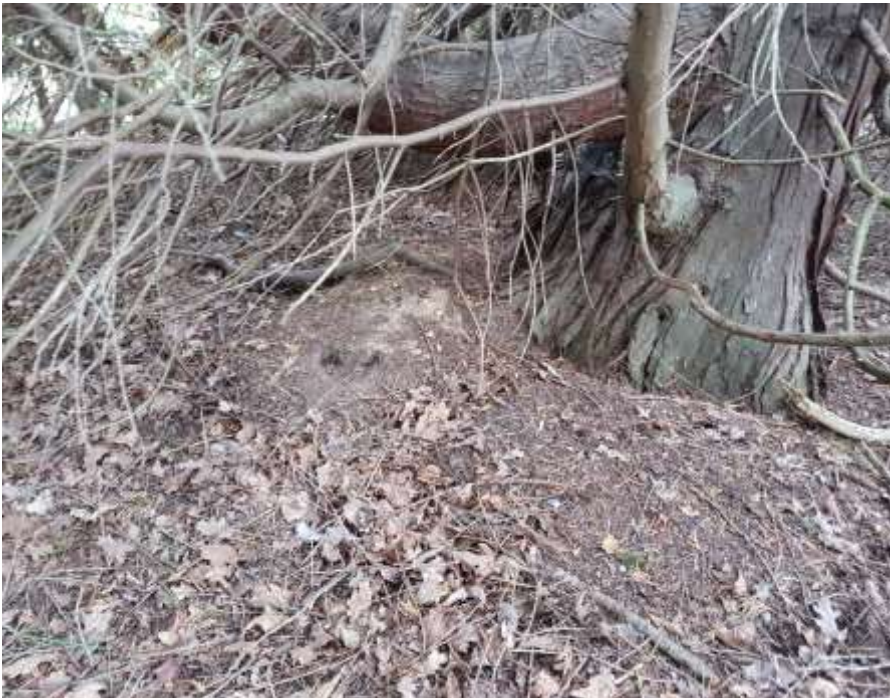
**T413/TAG: 4072**

This *Thuja plicata* displays recent movement, it has very close proximity to the property which is within the drop zone. It requires removal

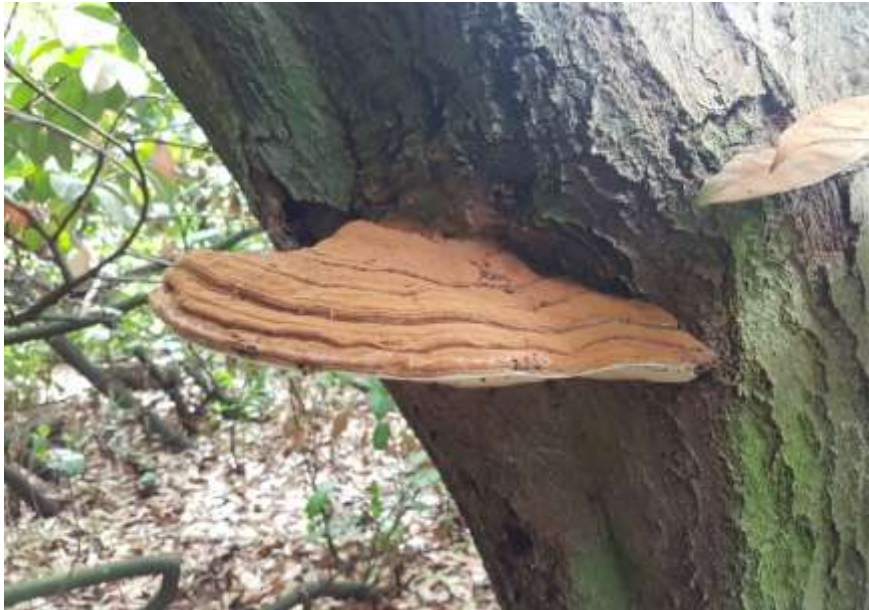
**T408/TAG: 4077**

This Beech appeared to be suffering, closer inspection revealed a decay fungi (*ganoderma aplanatum*) set in the stem. Pockets of decay were also found at the base. This specimen has a lean towards the driveway and requires removal.

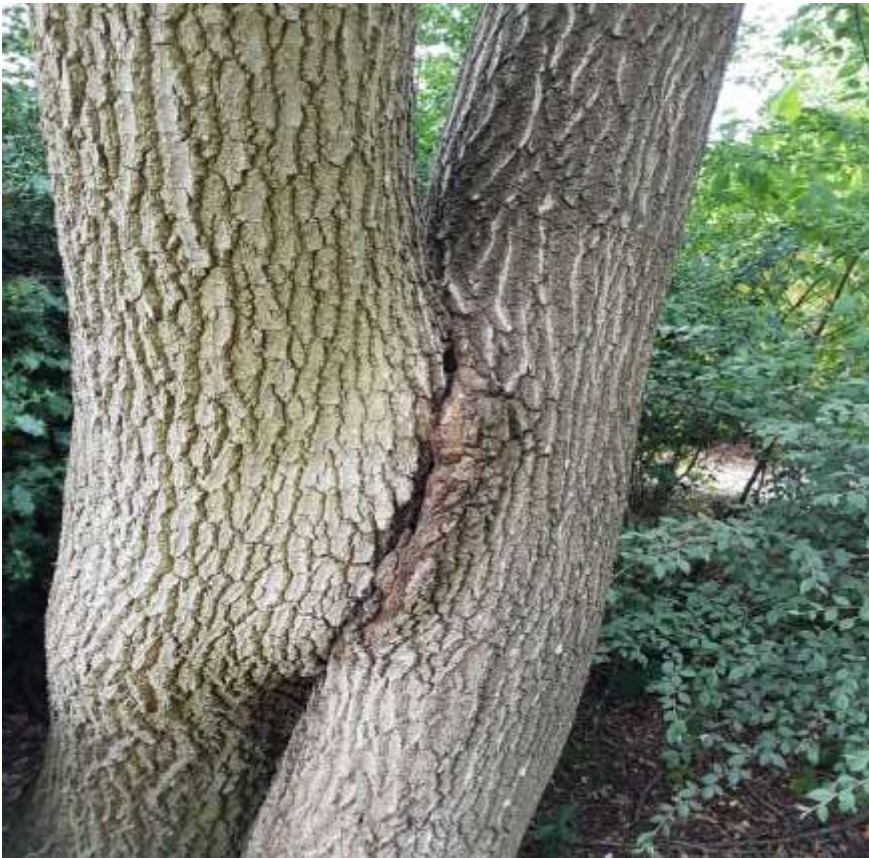
**T425+T426/TAG: 4085**

Two individual Oaks have fused. The fusion appears to be sound but will require close observation over the next 10 years. Bracing may become necessary to mitigate potential structural failure

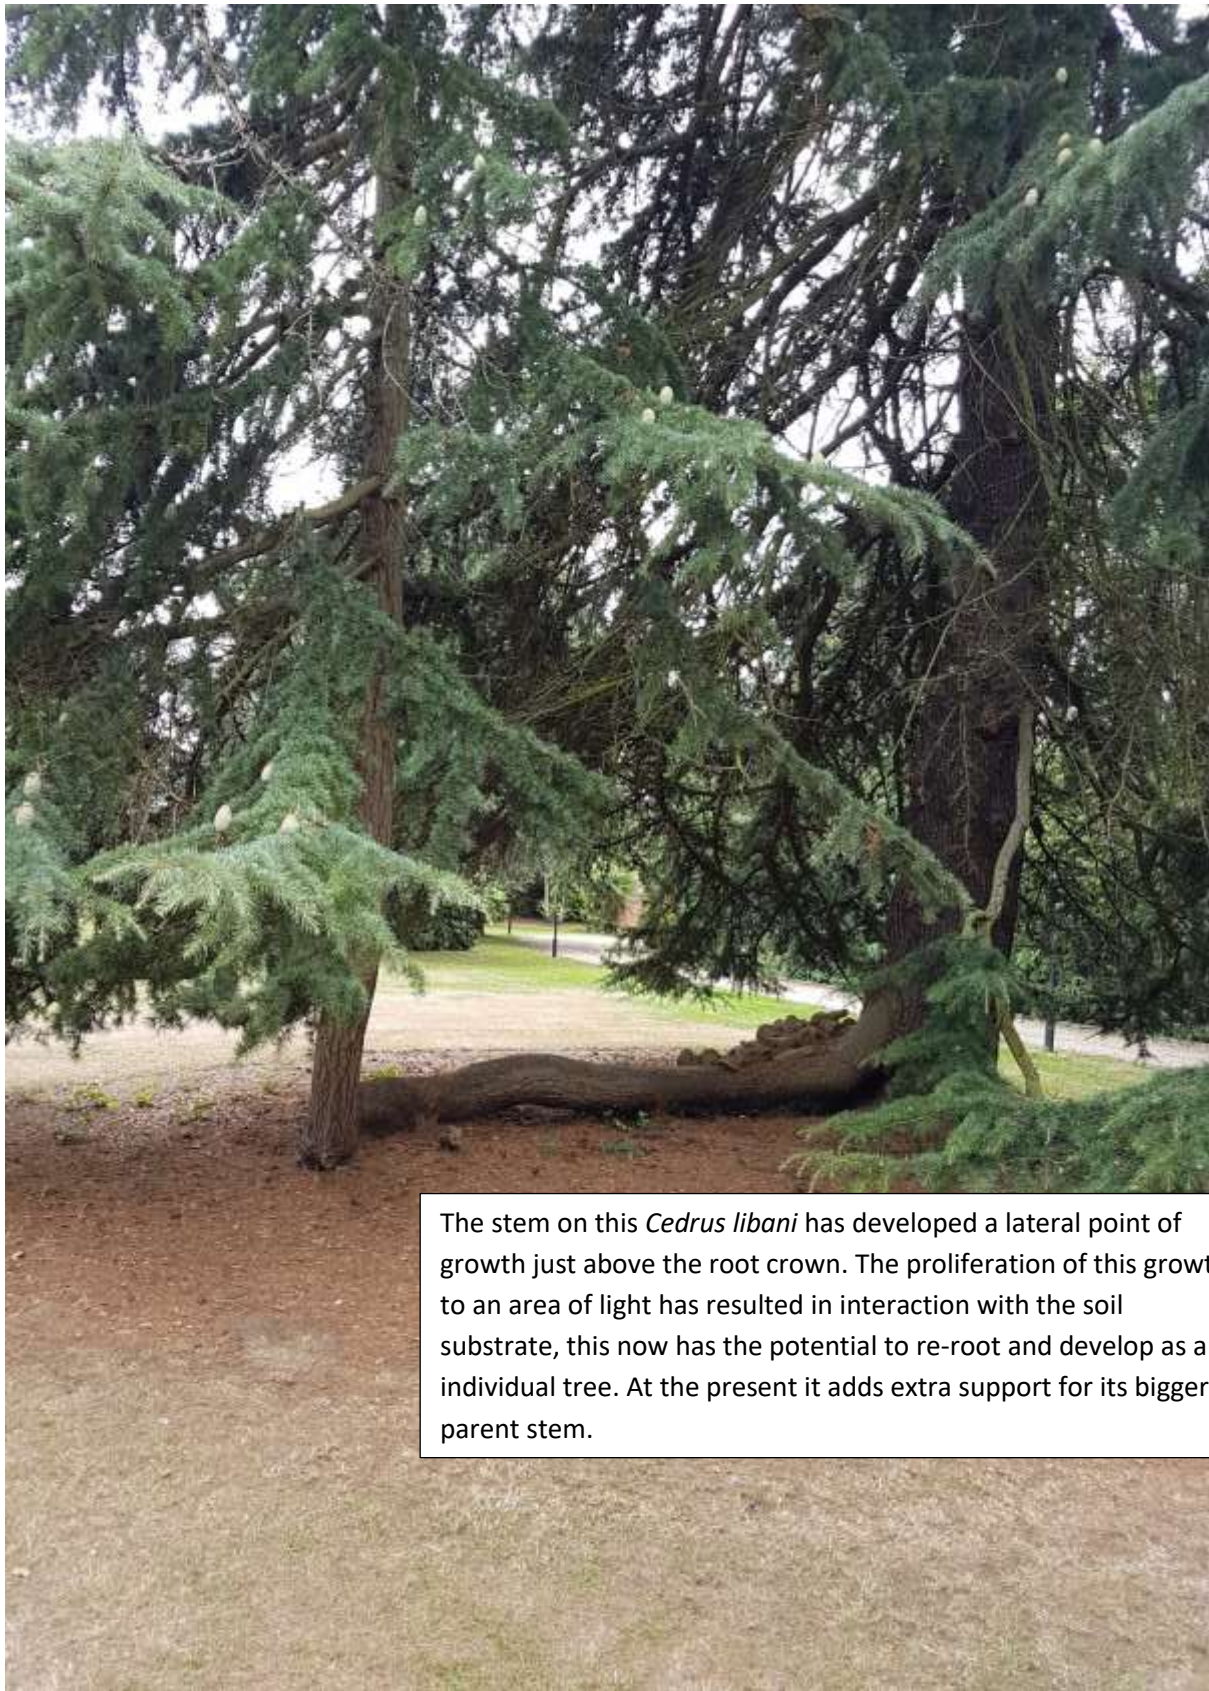
The stem on this *Cedrus libani* has developed a lateral point of growth just above the root crown. The proliferation of this growth to an area of light has resulted in interaction with the soil substrate, this now has the potential to re-root and develop as an individual tree. At the present it adds extra support for its bigger parent stem.

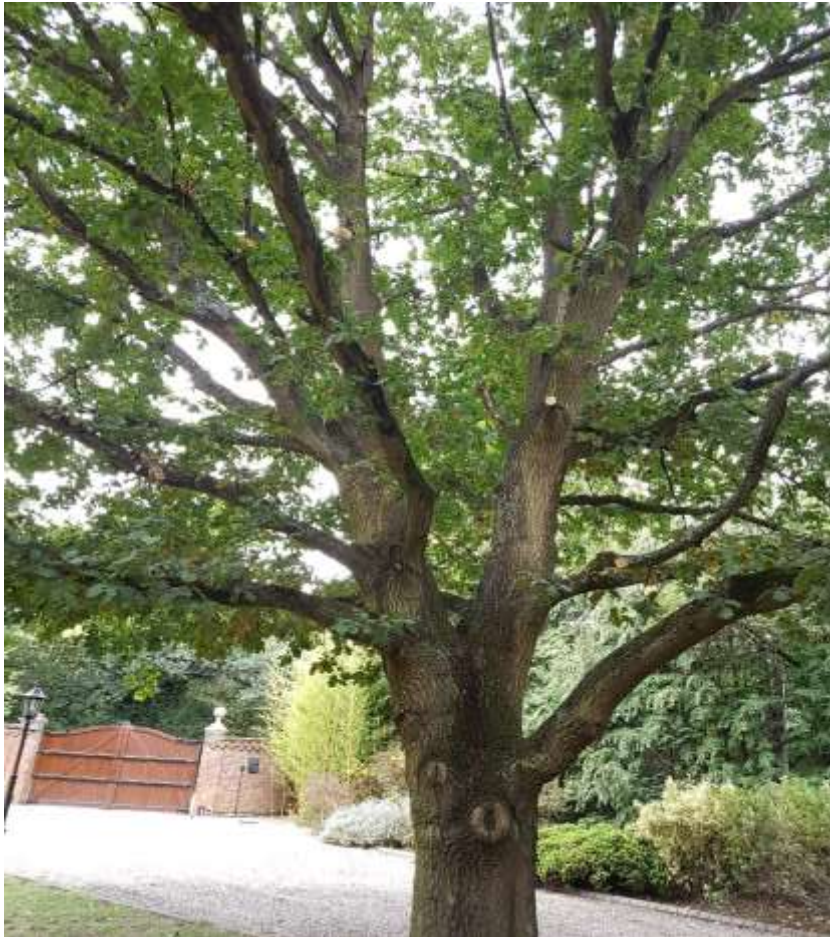
Map Reference: T389 / TAG: 4049

The fork of this Oak has a weakness that can be seen running from the crown break vertically into the main stem.

Supporting the twin leaders by bracing them against each other will help mitigate potential failure onto the driveway.
