Arboricultural Assessment

Report Reference: RECTOR001

Longacre Professional Arboricultural Consultancy

At the instruction of Helen and Mick Cryer, Longacre Professional Tree Consultancy has been asked to investigate the structural integrity of an English Oak (T1), opposite Northfields (house), Rectory Lane, Shenley, WD7 9BX. This request was based upon the potential for structural related issues within this tree.

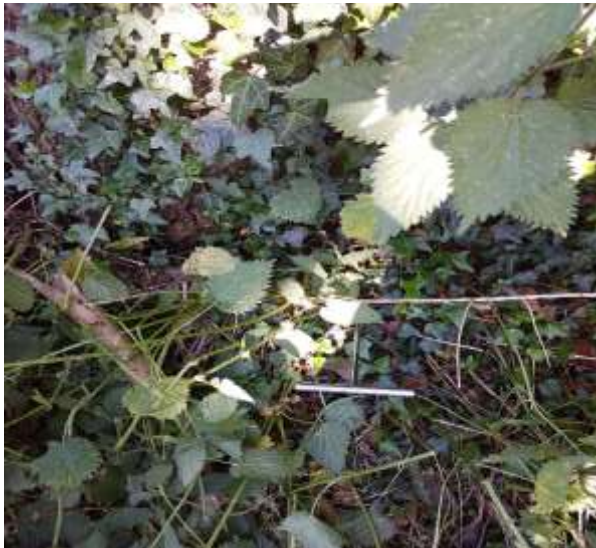
Base (REASONABLE): Probe and sounding mallet revealed no structural related issues. No visible fungal presence except of a minor basal cavity on property side of stem. Prolific Ivy presence. Structurally sound / systemically poor

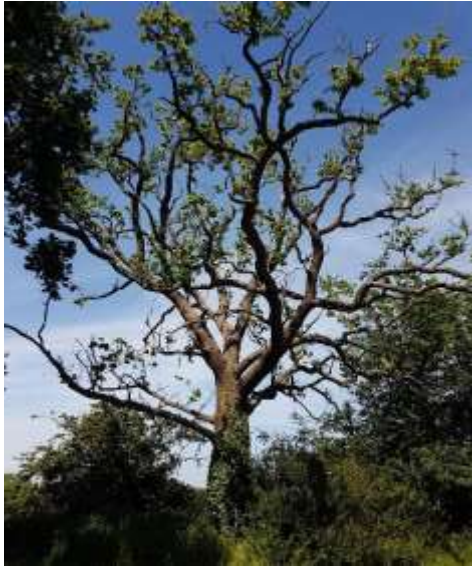
Stem (REASONABLE): No visible fungal or bacterial infection or audible hollow points. Structurally sound / systemically poor

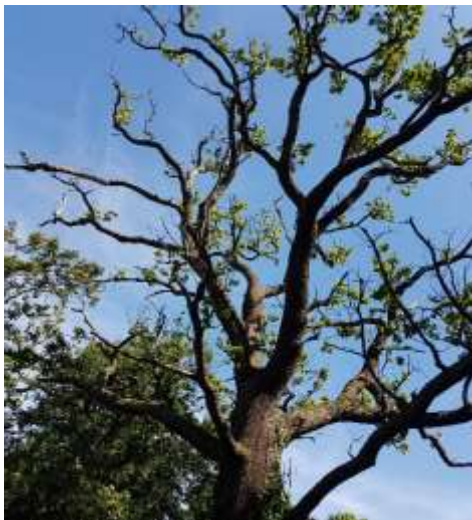
Crown (POOR): Consistent die-back throughout crown (lions-tail growth). No visible bacterial or fungal issues. Structurally poor / systemically poor

Root Area: No identifiable issues except potential for proliferation of systemic and structural issues identified through this report. There is a high potential that die back throughout this specimen is related to the vascular system which is associated to a substance leached into the rhizome.

Overall structure (POOR): Stem and root structure physiologically stable. Crown die back has potential for abscission with public space, carriageway within drop zone.

Overall physiology = (POOR): Systemic failure, final growth habit indicative of vascular failure. 0-5 year's life expectancy

Works Recommendations: **Crown reduction works would removal all active growth, there are no points that this specimen can be brought back to reinvigorate and assist dormant bud activation - Fell to ground level.**
