Longacre Professional Arboricultural Consultancy

Arboricultural Survey, Recommendations and Cyclical Management Plan

08/09/2018

Report Reference: LYE001

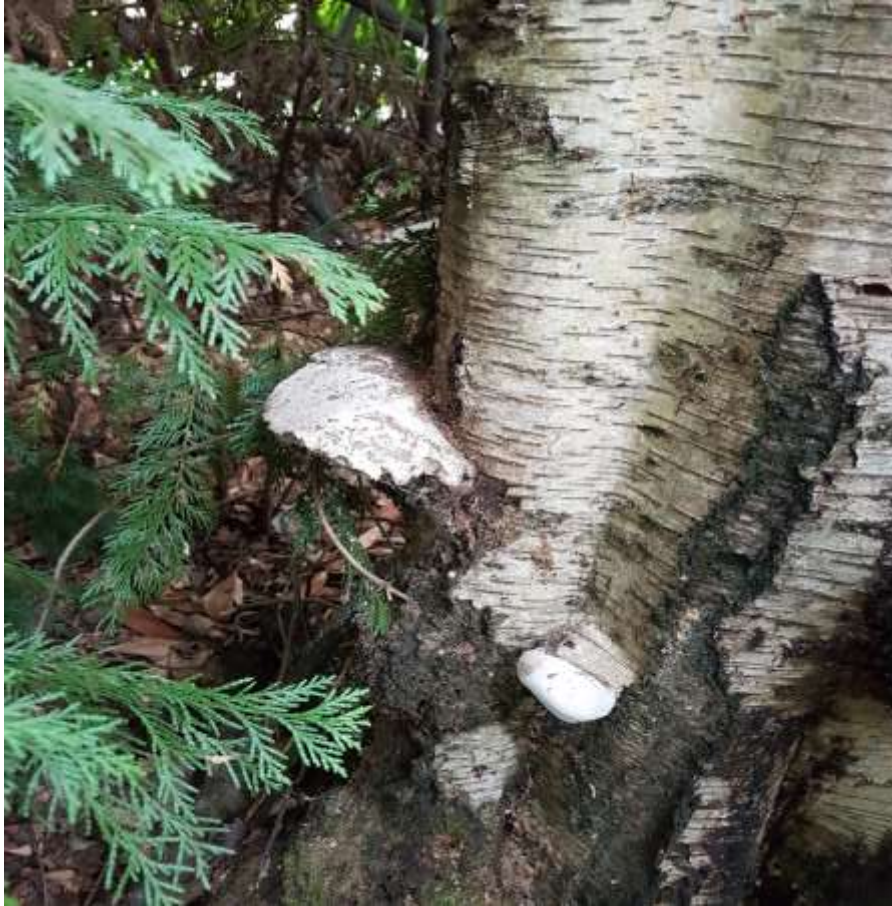
T402/TAG: 4061

Piptoporus betulinus is a fungal strain that is very fast acting, breaking down the structural stability of the infected Birch. Removal becomes necessary when a public space is within the drop zone of the infected host.

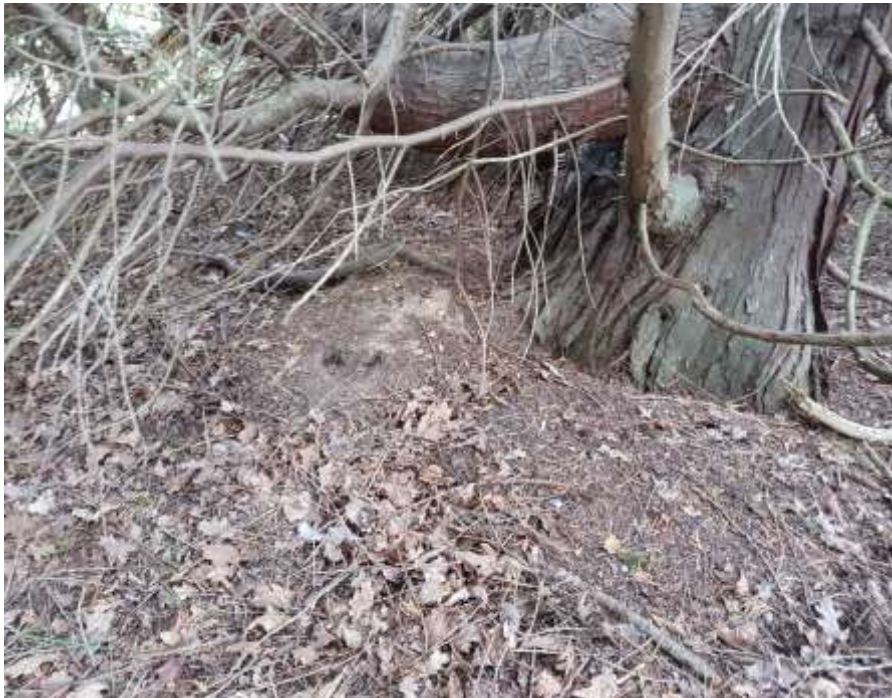
T413/TAG: 4072

This *Thuja plicata* displays recent movement, it has very close proximity to the property which is within the drop zone. It requires removal

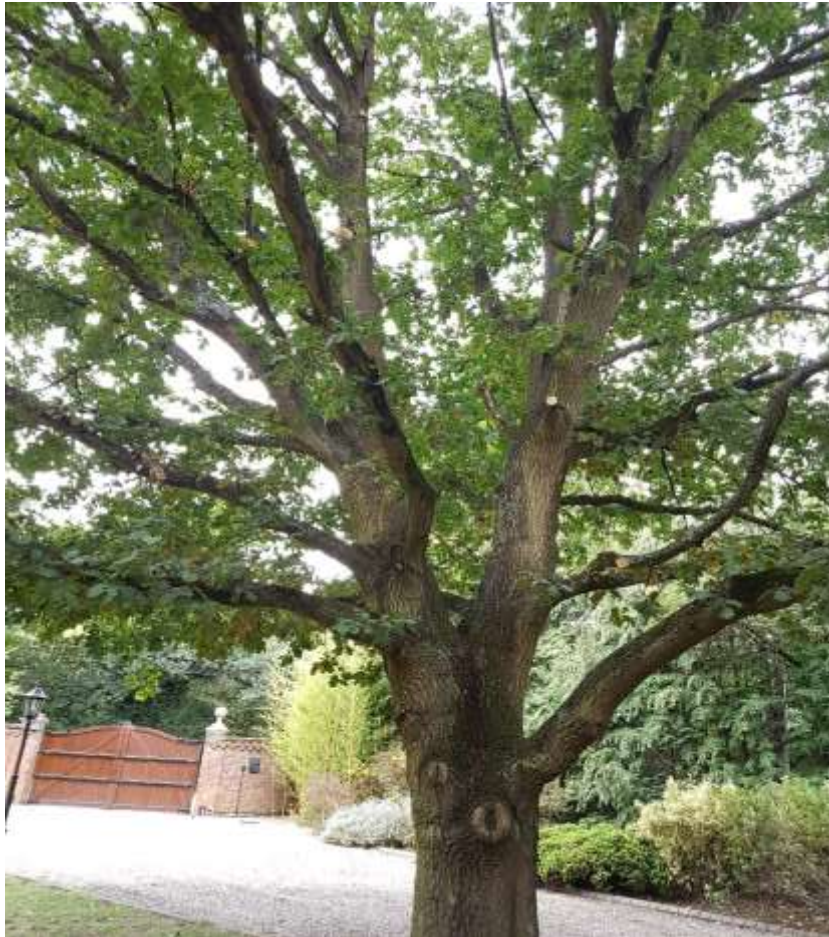
Map Reference: T389 / TAG: 4049

The fork of this Oak has a weakness that can be seen running from the crown break vertically into the main stem.

Supporting the twin leaders by bracing them against each other will help mitigate potential failure onto the driveway.
