Arboricultural Appraisal

68-70 Queens Drive N4 2XR

Report Reference: QUEENSDR.AA.001

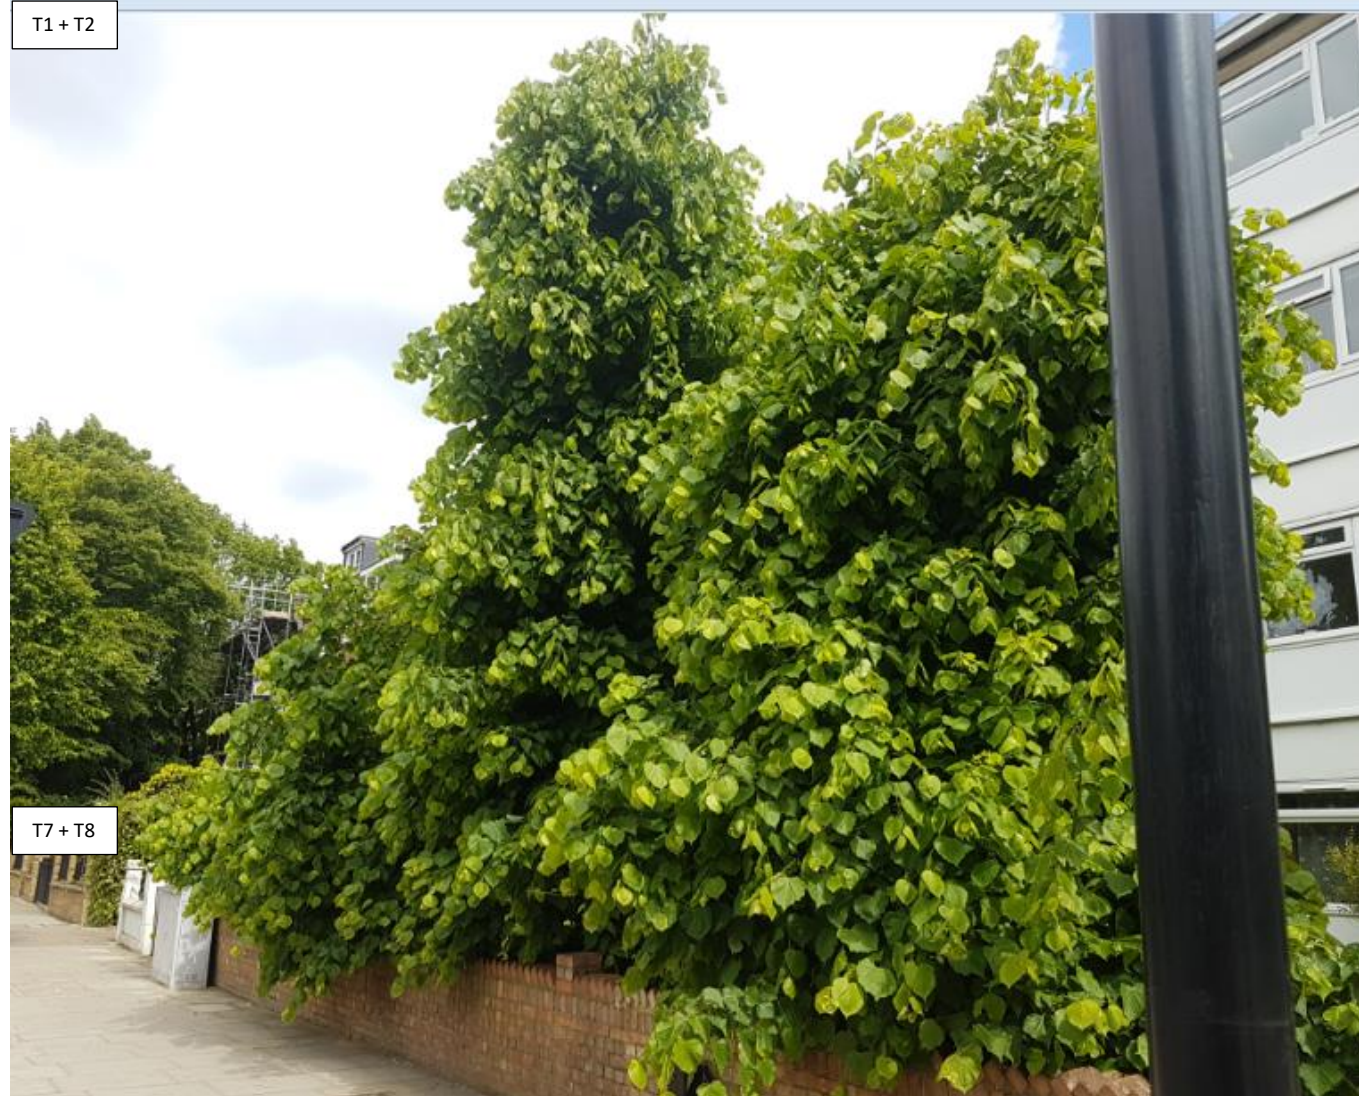
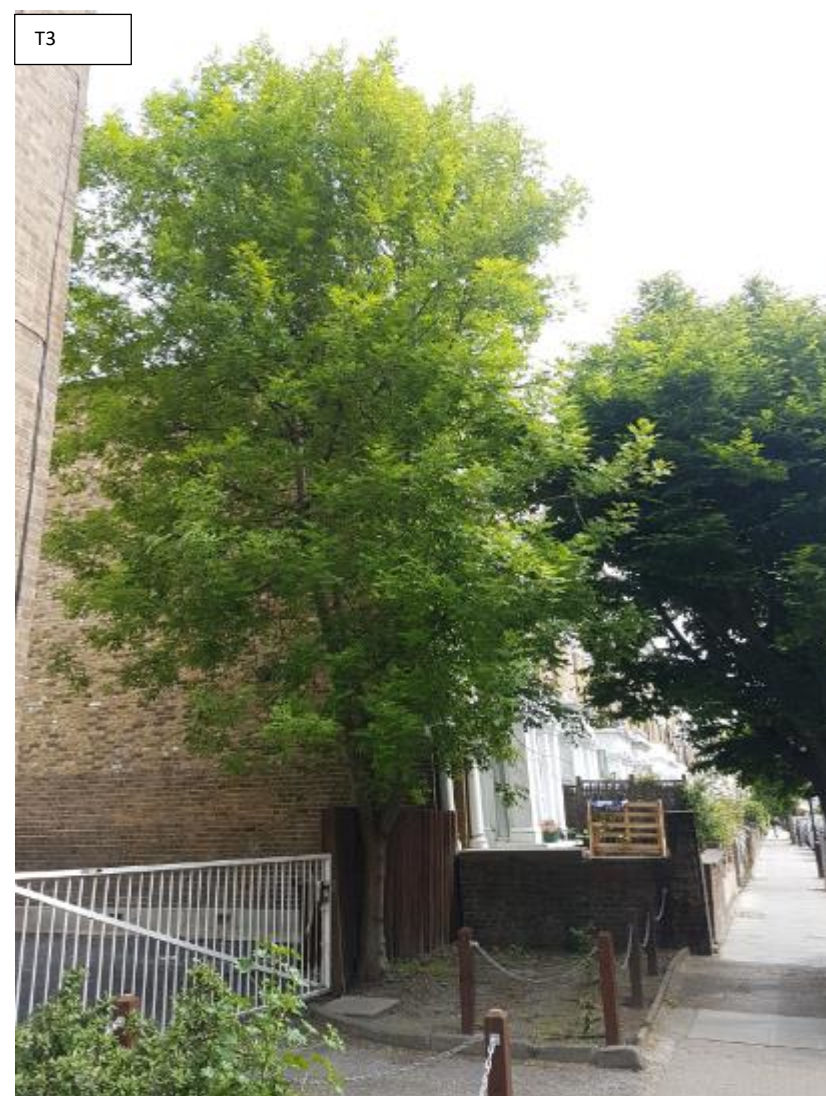
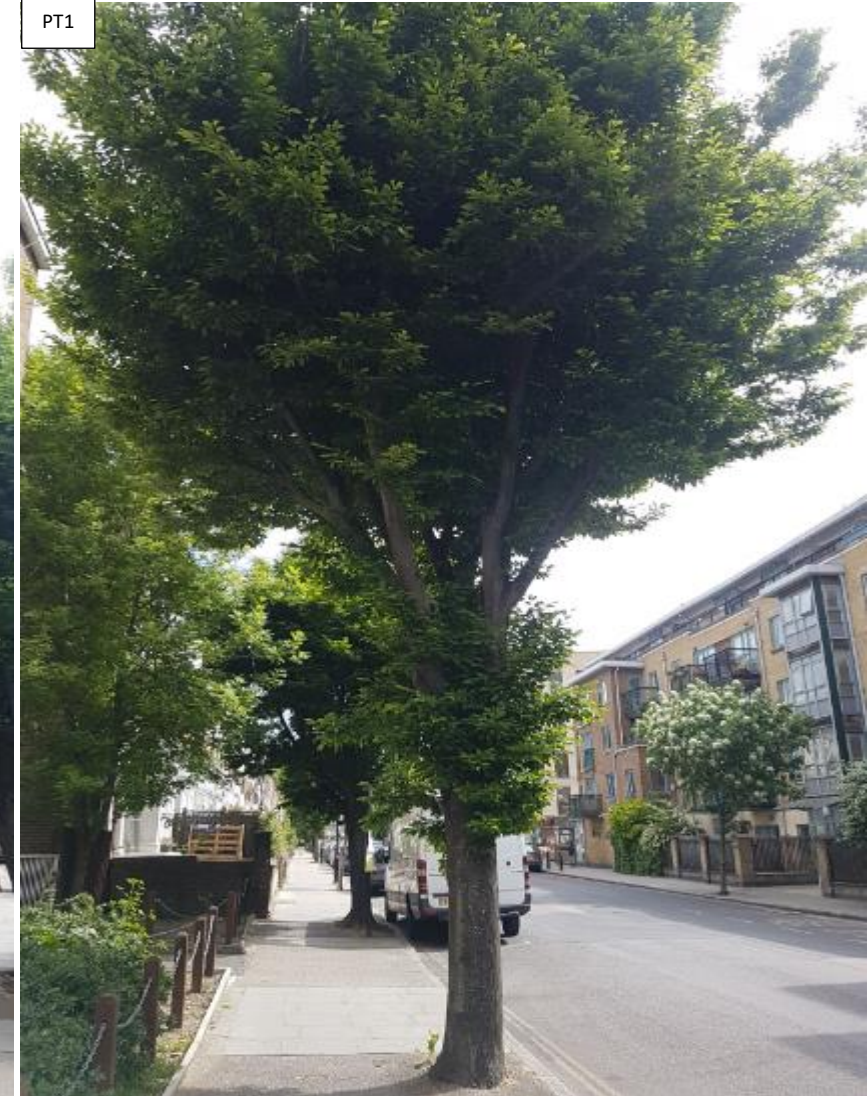
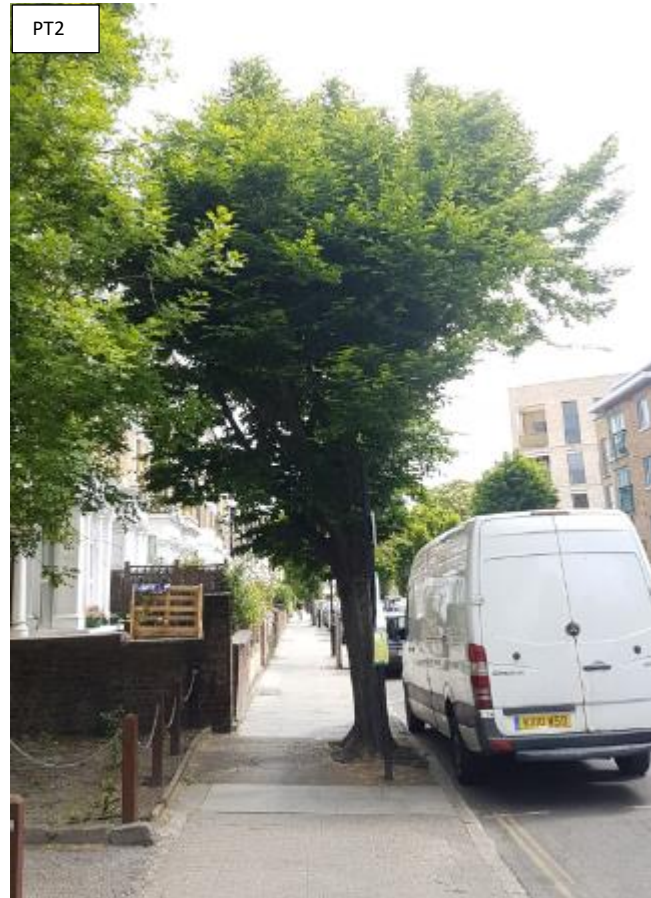
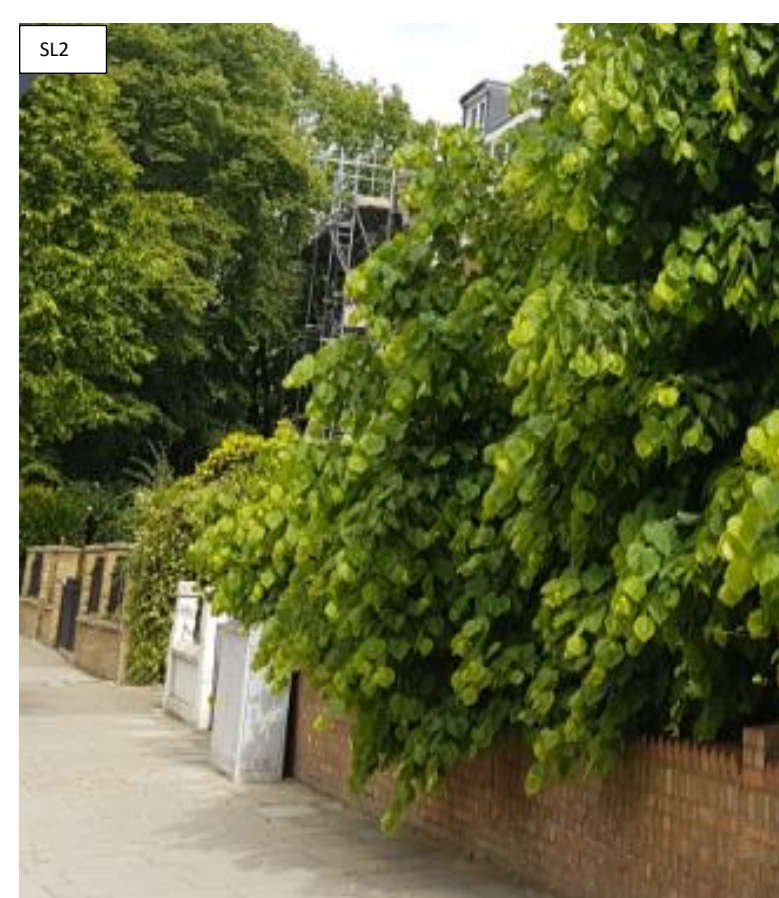
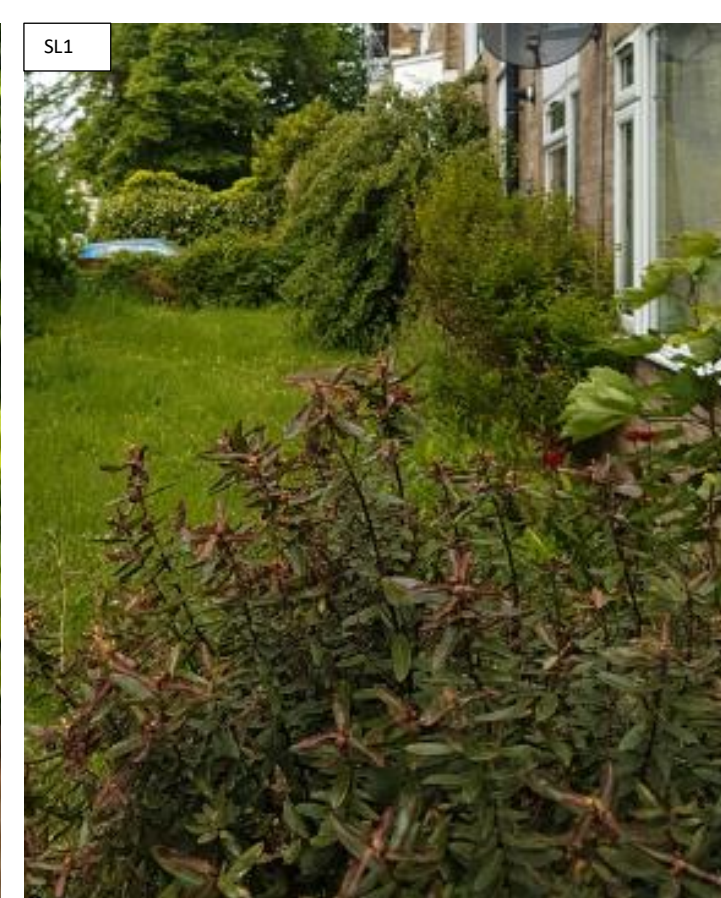
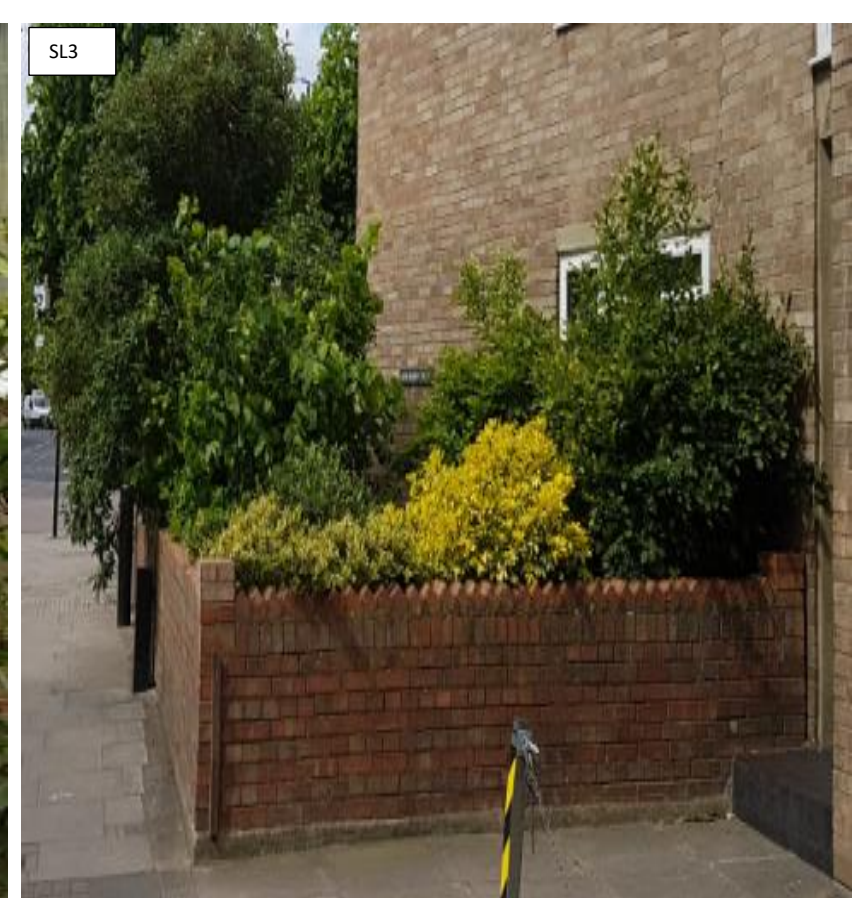
Derbin Court, 68-70 Queens Drive , N4 2XR												
Map REF	Species	Height (m)	DBH (mm)	Crown Spread (m)	Distance from Property (m)	Ownership	Age	Condition	Past Management/Comments	Recommended Works	Subsidence Risk Factor	NHBC – Area of influence
T1	Lime	5	230	2	6	Derbin Court	SM	Fair	Pollard. Managed as a pollard due to proximity to structure	Remove epicormic growth June 2020 Re-pollard October 2021 (inc epicormic growth). June 2022, 2023 remove epicorimic growth. Feb 2024 Re-pollard (inc epicormic growth)	MODERATE	Y
T2	Lime	4	220	2	6	Derbin Court	SM	Fair	Pollard. Managed as a pollard due to proximity to structure	Remove epicormic growth June 2020 Re-pollard October 2021 (inc epicormic growth). June 2022, 2023 remove epicorimic growth. Feb 2024 Re-pollard (inc epicormic growth)	MODERATE	Y
T3	Ash	7	210	3	5	Derbin Court	EM	Good	None (see Subsidence risk factor)	Reduce by 20% crown volume October 2020 Reduce by 20% crown volume October 2023	HIGH	Y

SL1	Mixed	1	N/A	N/A	0.1	Derbin Court	N/A	Good	N/A / Retain at current dimensions	N/A	N/A	N
SL2	Lime	1.5	N/A	N/A	6	Derbin Court	N/A	Good	N/A / Retain at current dimensions	Remove epicormic growth 2020, 2021, 2022, 2023, 2024	MODERATE	N
SL3	Mixed	1.5	N/A	N/A	0.1	Derbin Court	N/A	Good	N/A / Retain at current dimensions	N/A	N/A	N
PT1	Hornbeam	8	290	5	5	Local authority	SM	Good	N/A	Notify local authority of potential negative impact to property	HIGH	Y
PT2	Hornbeam	7	305	4	7	Local authority	EM	Good	N/A	Notify local authority of potential negative impact to property	HIGH	Y
