Arboricultural Appraisal

Hatfield Broad Oak Parish

Report Reference: TS00123_HATBR_5888

Date of inspection: 22/04/2024

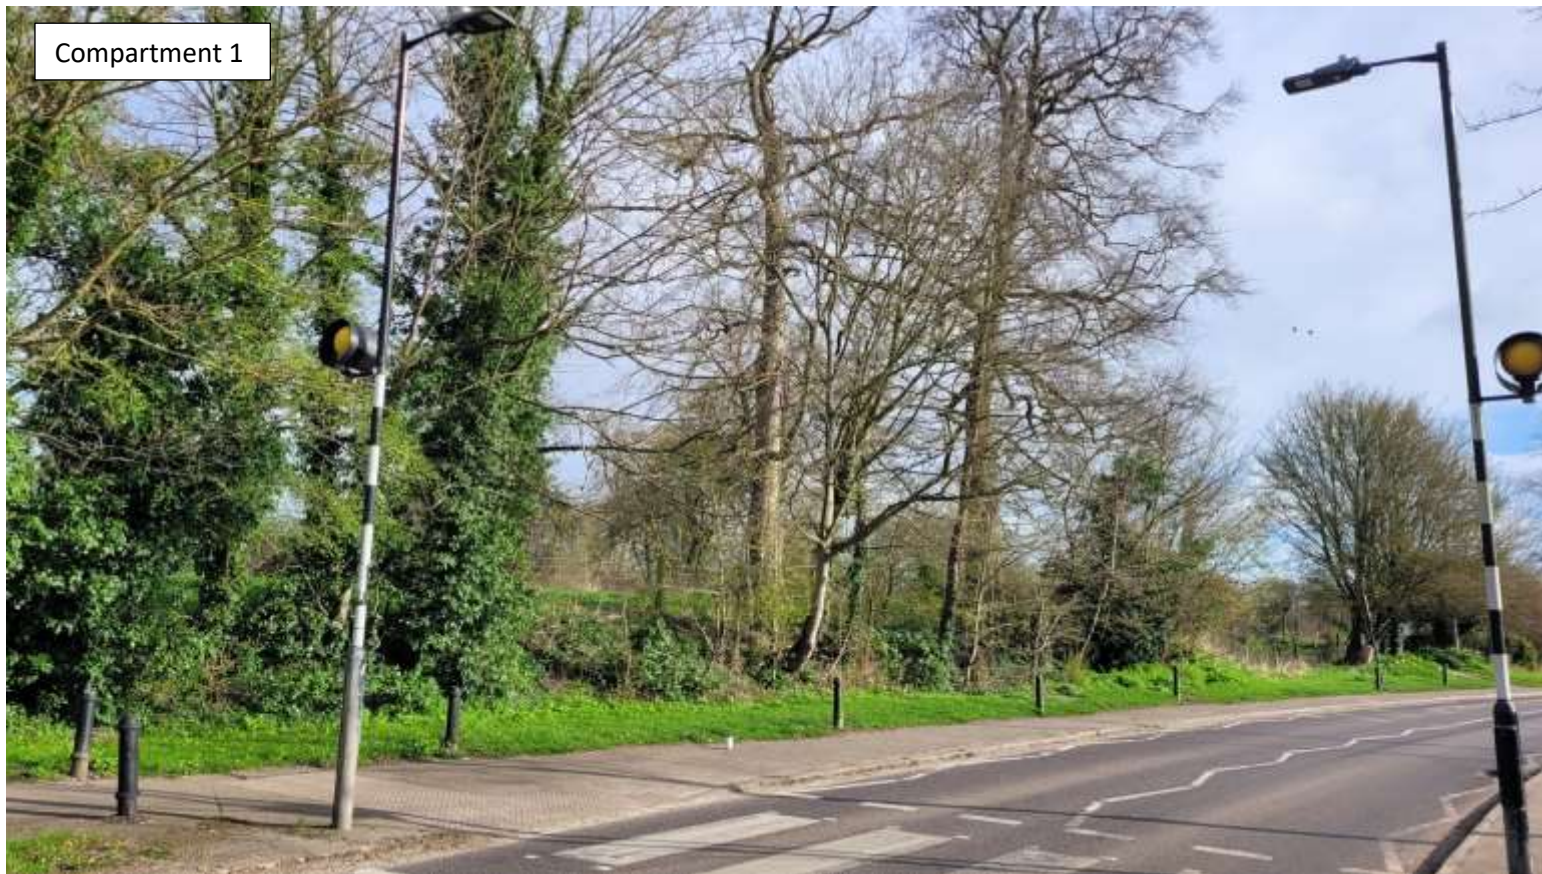
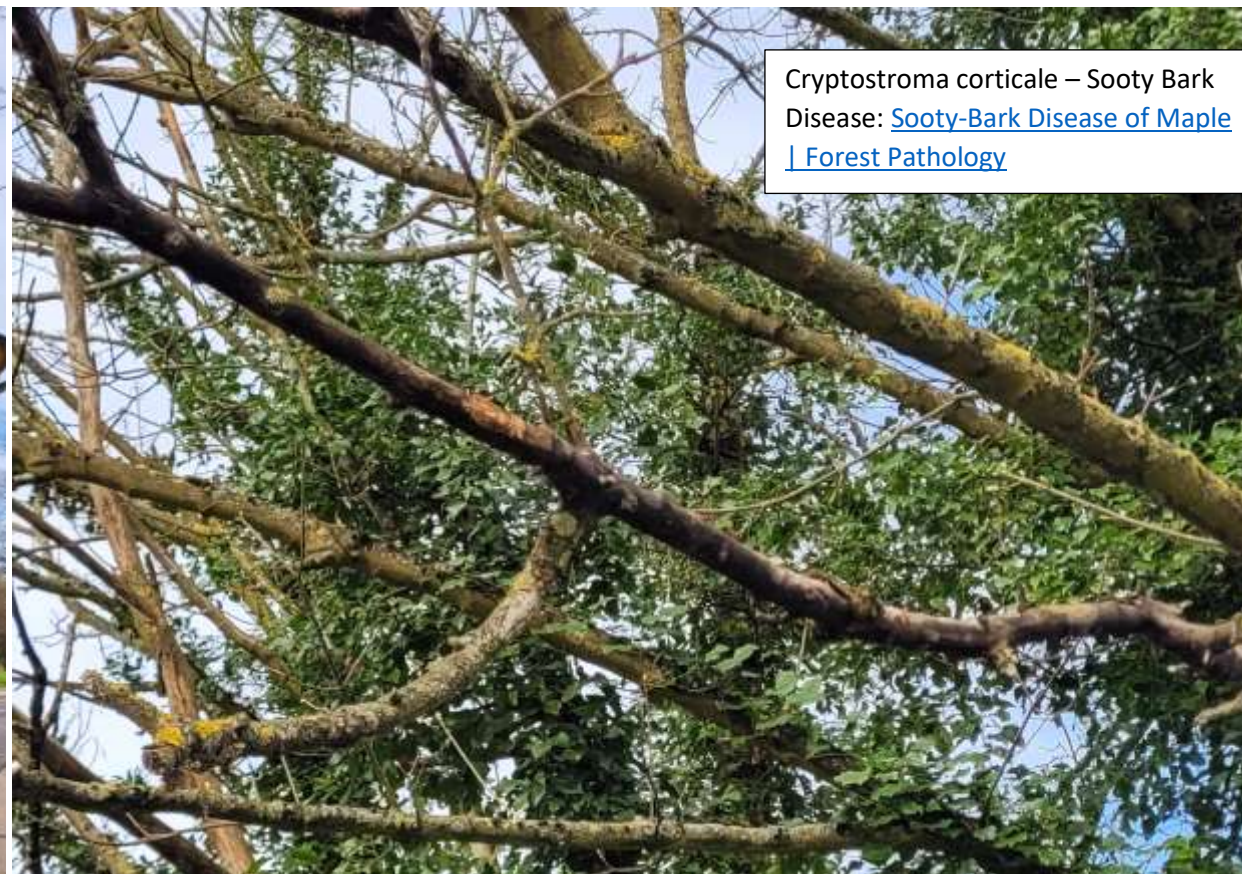
COMPARTMENT 1 OVERVIEW

Sooty bark present within stock this will require monitoring of the Sycamore on an annual basis to gauge the progression. Low growth over road will be a restriction to high sided vehicles sometime within the next 12 month. Flail works apparent but not to extra heavy vehicle height i.e.4.6m.

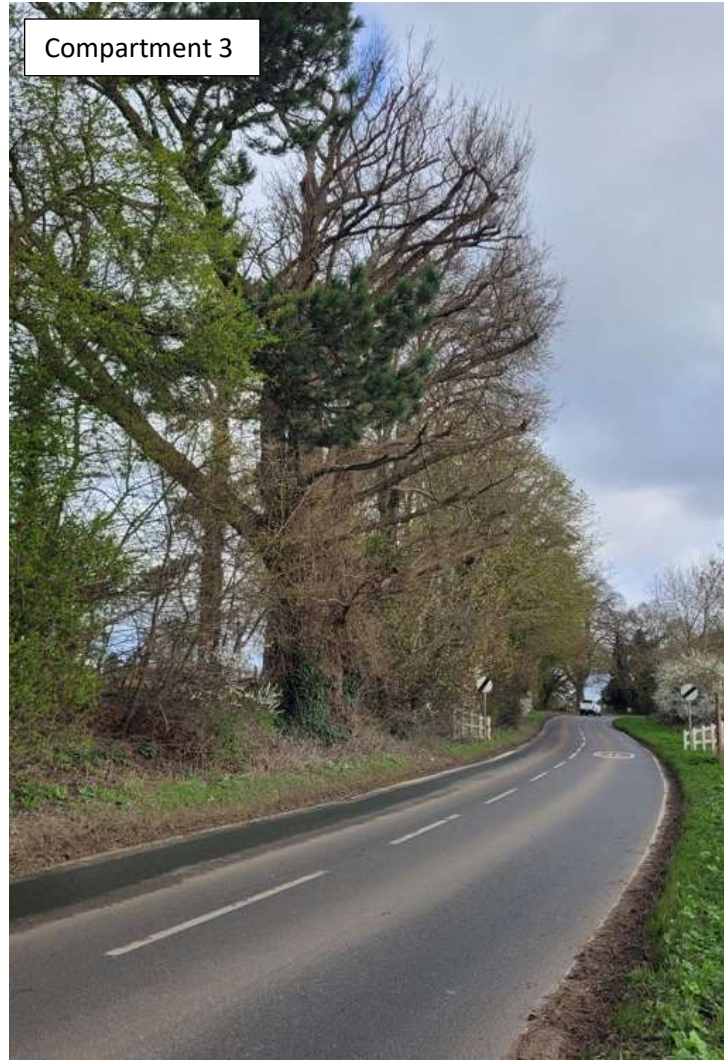
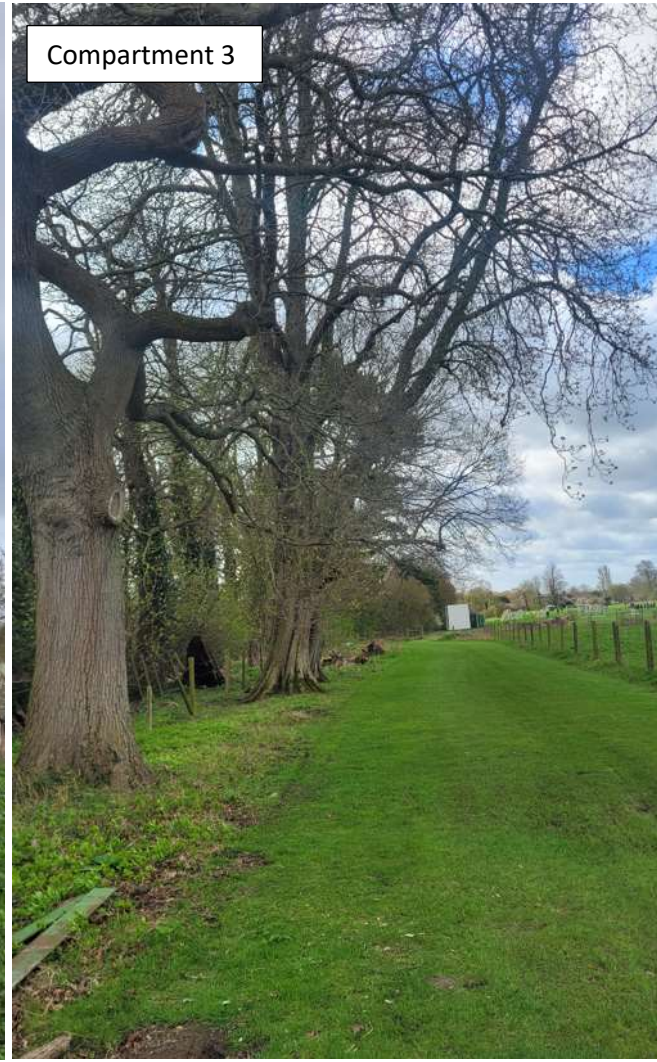
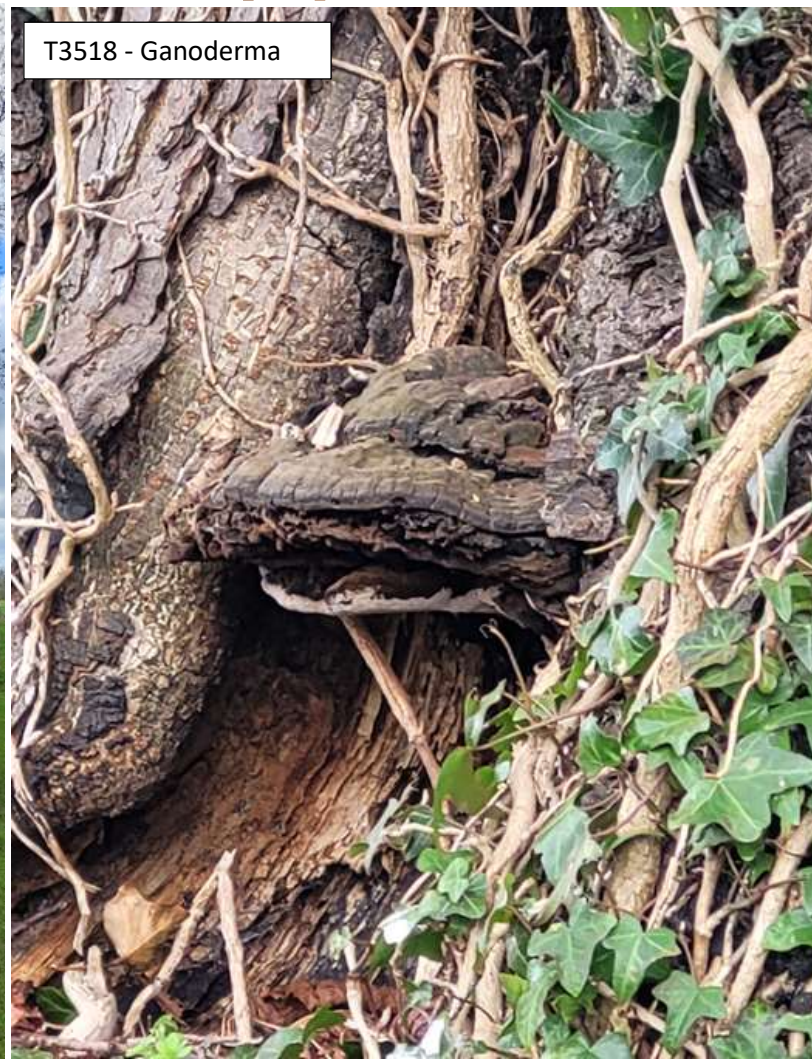
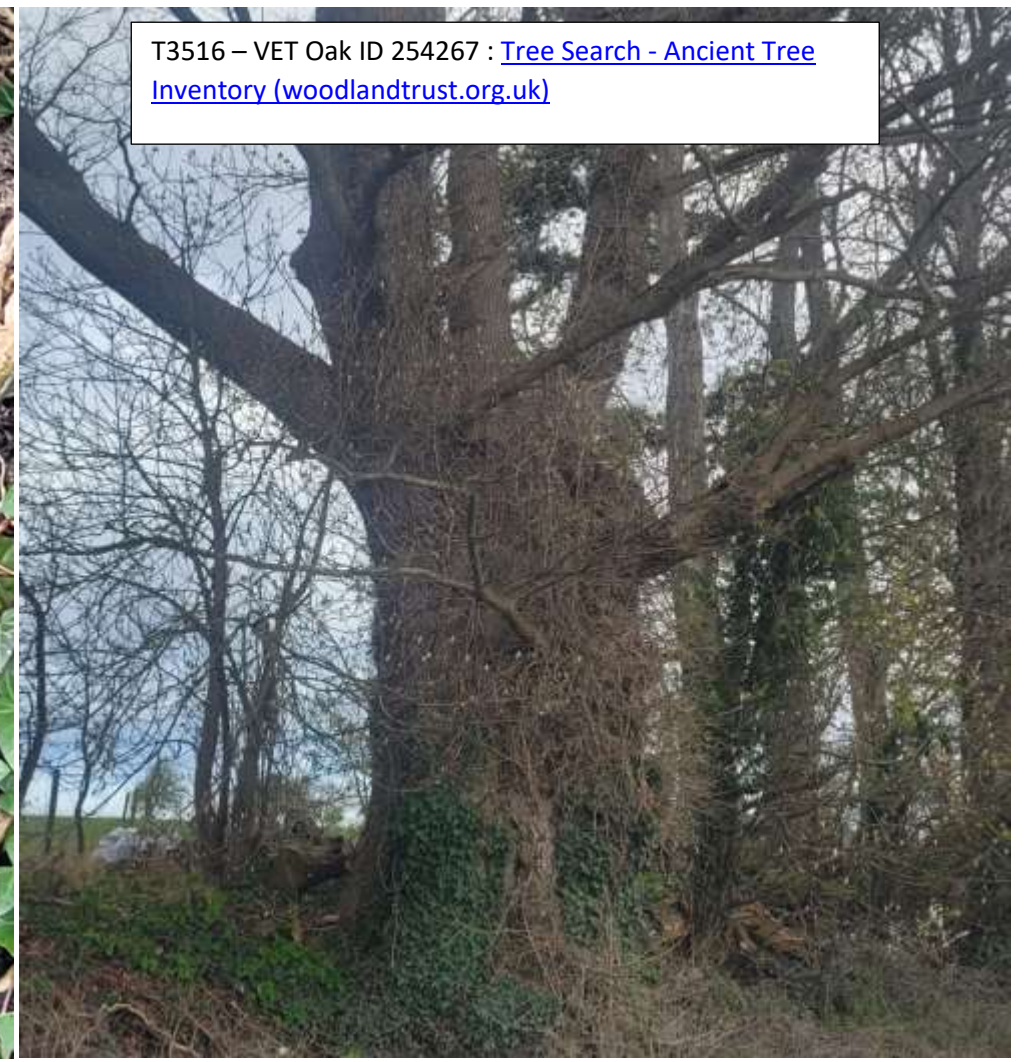
COMPARTMENT 3 OVERVIEW	Sooty bark present within stock this will require monitoring of the Sycamore on an annual basis to gauge the progression. Low growth over road will be a restriction to high sided vehicles sometime within the next 12 month. Flail works apparent but not to extra heavy vehicle height. Group of Horse chestnut found to be in poor condition. Collapse of these would potentially be onto the public carriageway, mitigation works, and annual monitoring required.

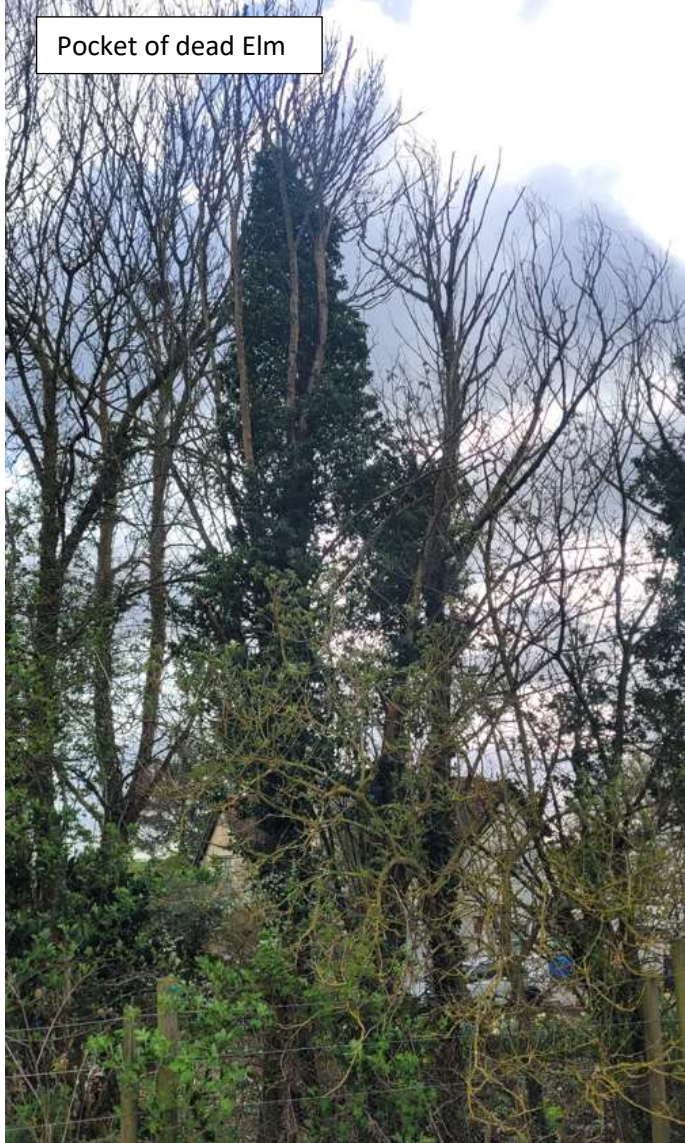
Pocket of dead Elm

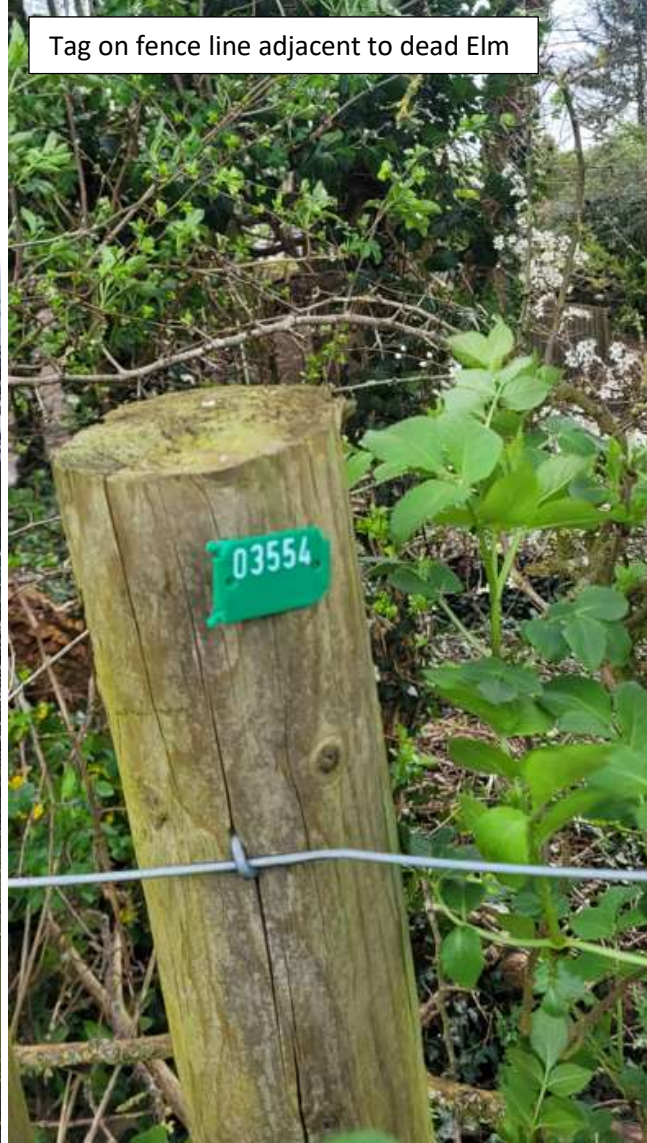
Tag on fence line adjacent to dead Elm

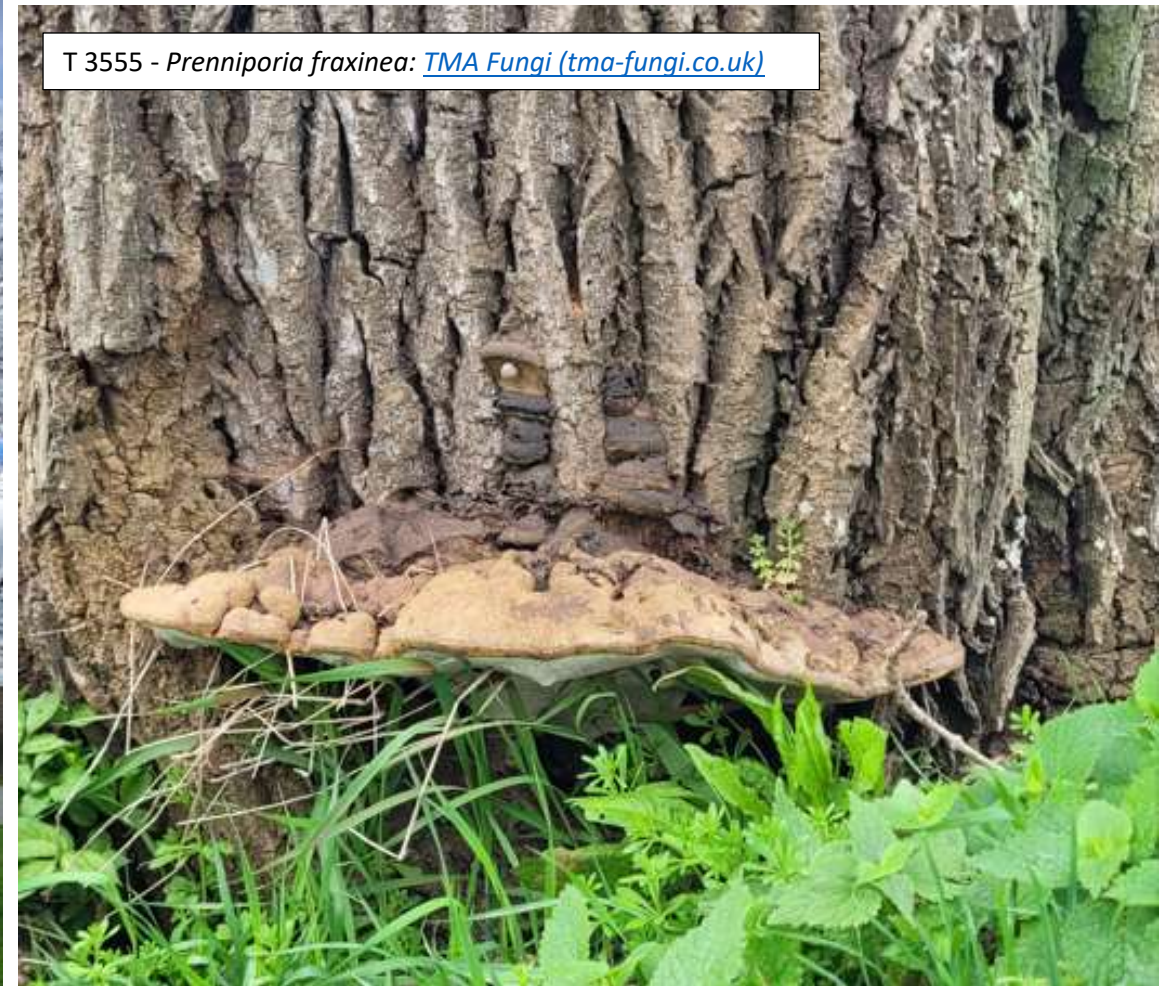
T 3555 - *Prenniporia fraxinea*: [TMA Fungi \(tma-fungi.co.uk\)](http://TMA Fungi (tma-fungi.co.uk))

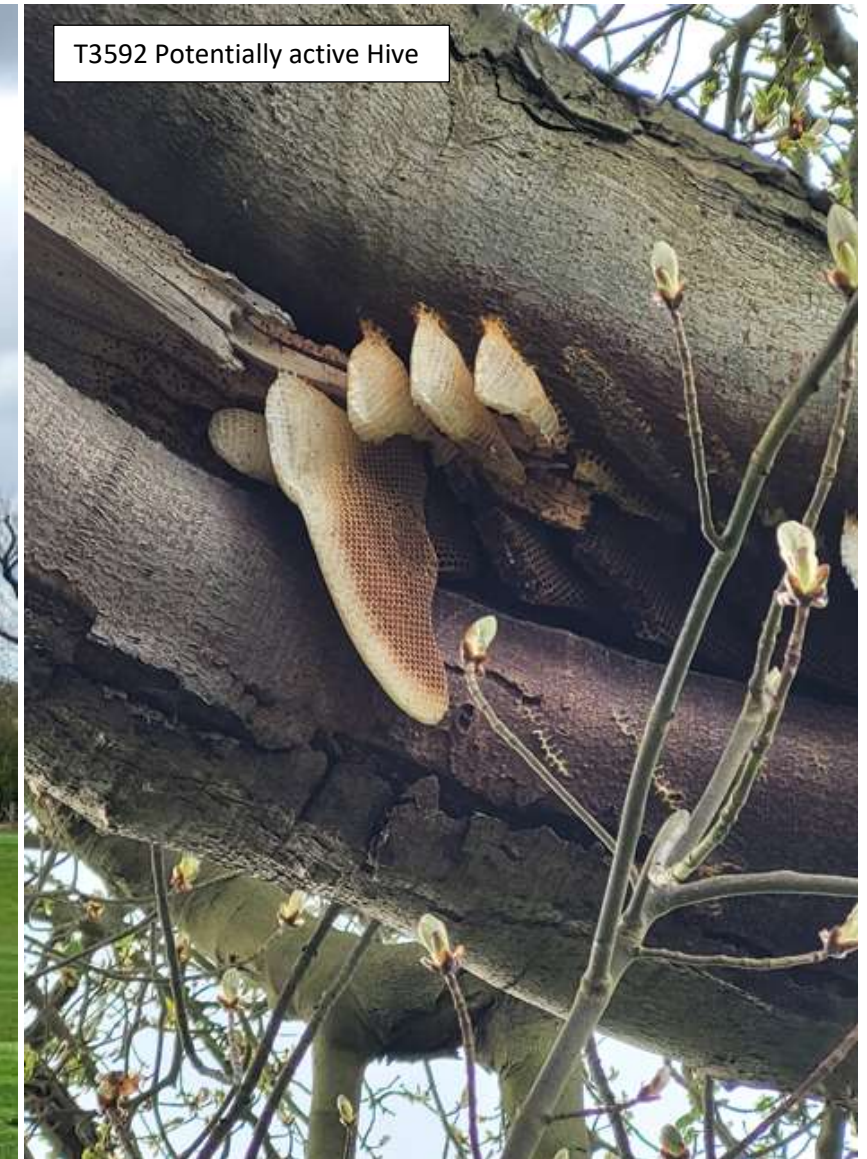
T3592 Potentially active Hive

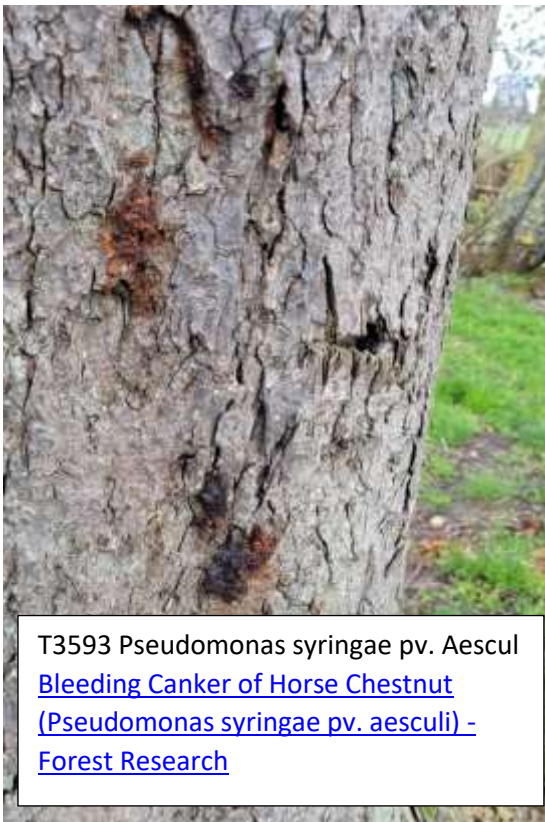
T3593 *Pseudomonas syringae* pv. *Aescul*
[Bleeding Canker of Horse Chestnut](#)
[\(*Pseudomonas syringae* pv. *aesculi*\) -](#)
[Forest Research](#)
