Tree Survey Condition Report with Recommendations

Site Address: 57A-D Norfolk Road, Seven Kings, Essex, IG3 8LH

Report by Gary O'Sullivan

Longacre Report Reference: IG3 8LH 001

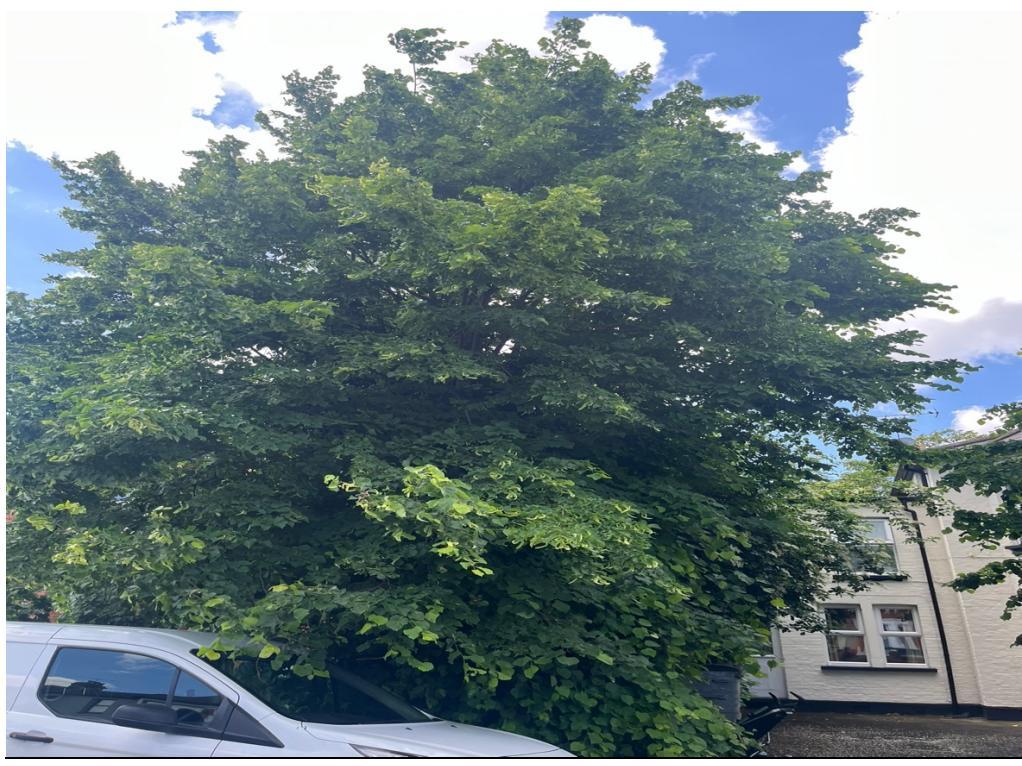
### <u>Photo 1</u>

Tree T1, Front elevation, showing low canopy over the footpath and highway.

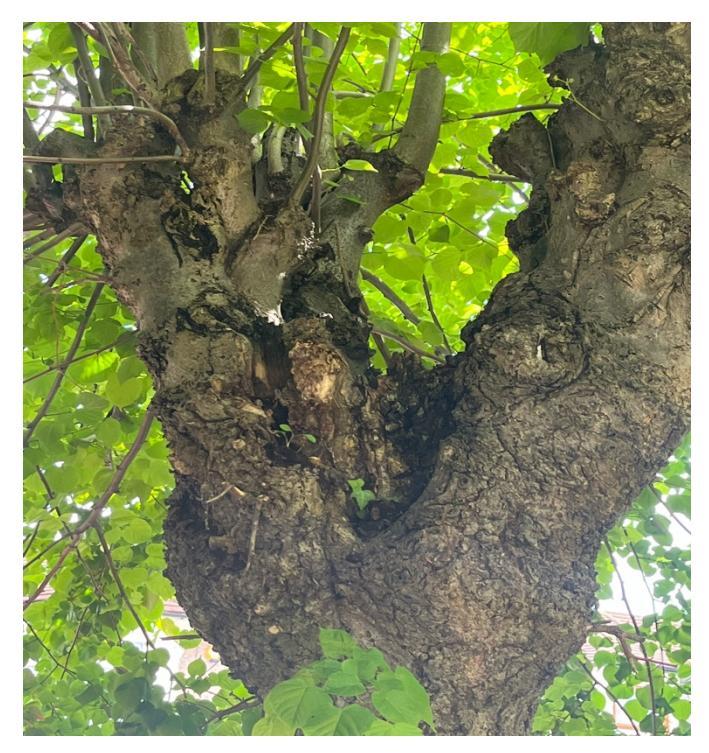
### Photo 2

Tree T2, photo showing decay at old pollard points which could lead to further decay at these points and possible weak spot for future growth. Pollard to a single stem, just below old pollard points, beneath decay section.

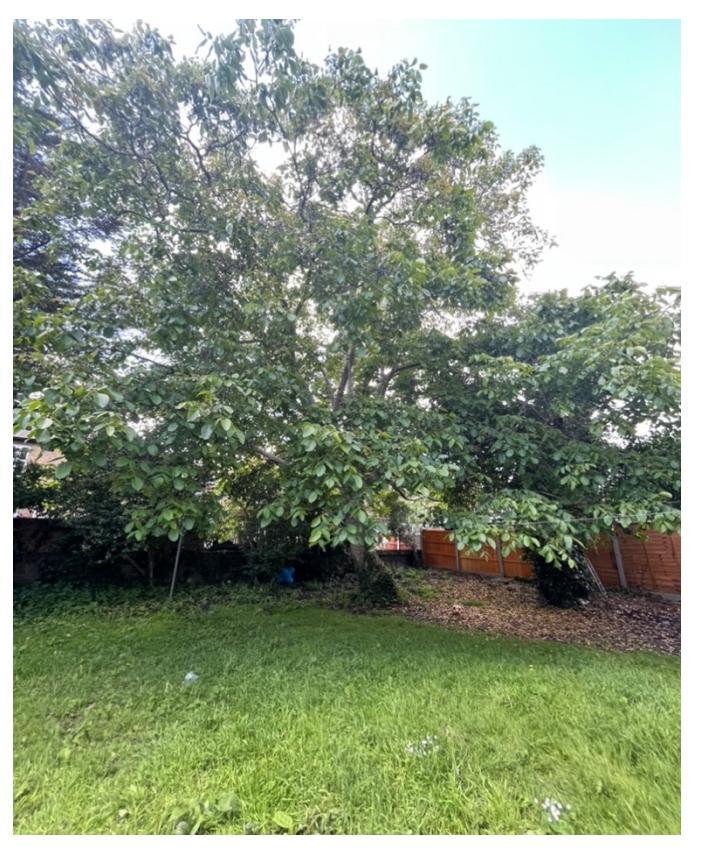
### <u>Photo 3</u>

Tree T4 Specimen tree focal point as you enter the rear garden.

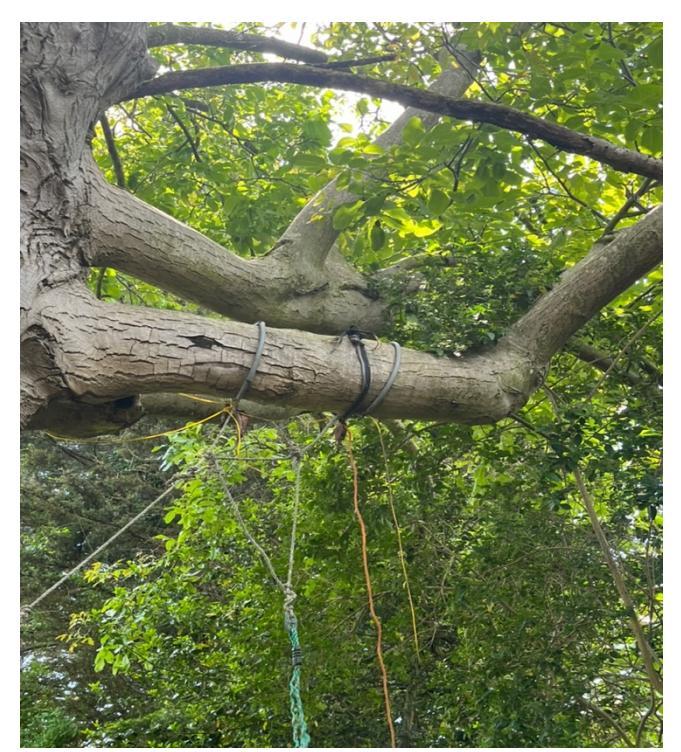
### <u>Photo 4</u>

<u>Tree T4 showing old washing line or rope swing around</u> <u>lower lateral branch,</u>

Remove this rope/wire.

Can be retied with knot or sling that doesn't constrict the growth of the branch and will not cause damage.

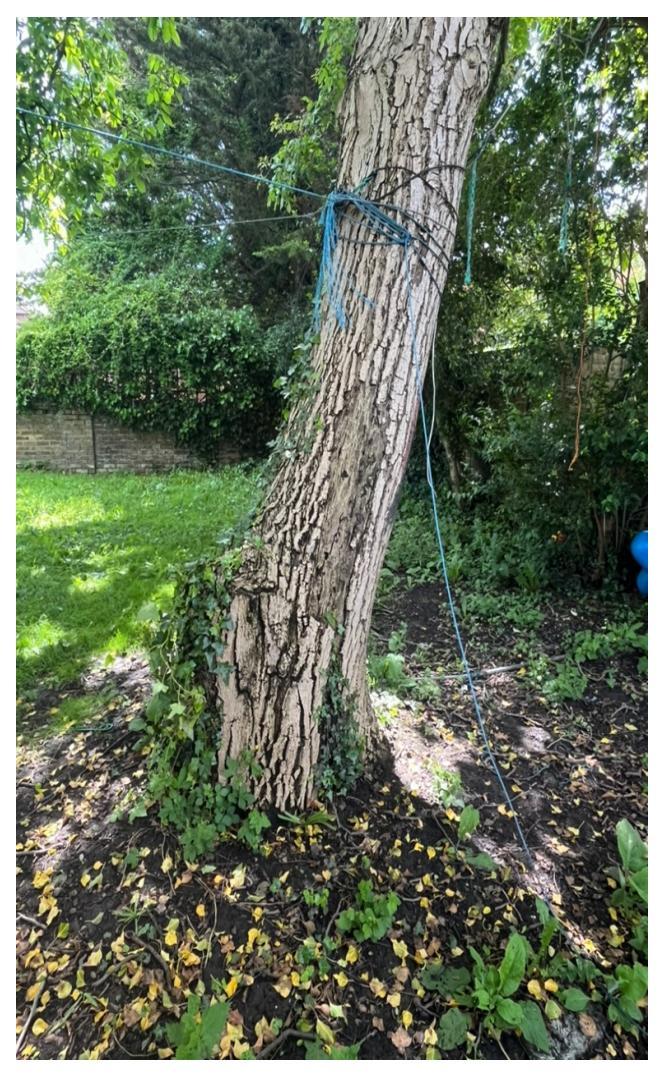
### Photo 5

Tree T4, showing washing line tied around the main stem,

This can be retied using a knot or sling that doesn't restrict the growth and will not cause future damage

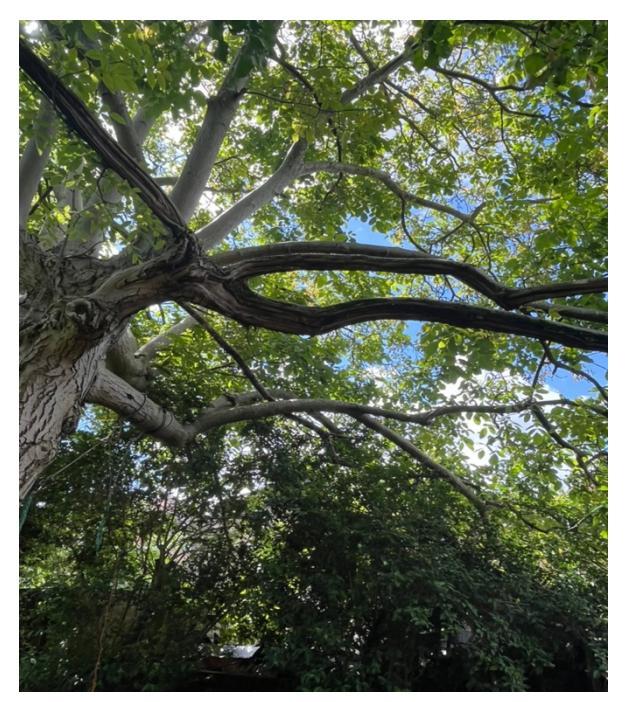
### <u>Photo 6</u>

Tree T5, Scarring on X 3 lower limbs.

Remove X 3 damaged limbs, back to old pruning point at 1 meter stump.

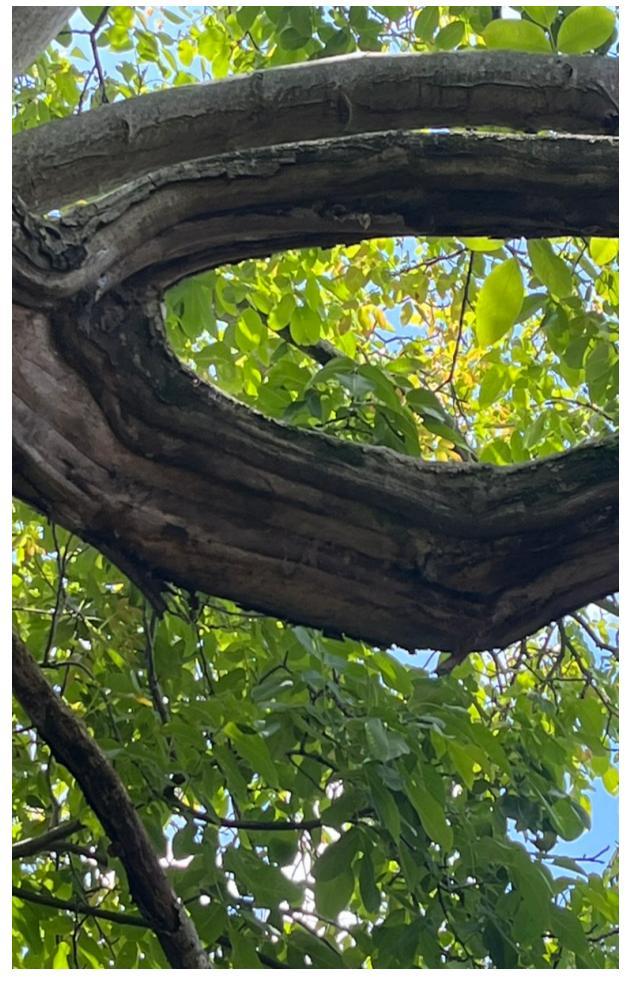
### <u>Photo 7</u>

Tree T5 Close up of scarring and wounds beneath X 3 lateral branches
