Arboricultural Assessment

1 Kensington Gate, London W8

Report Reference: AA/001/KEGA

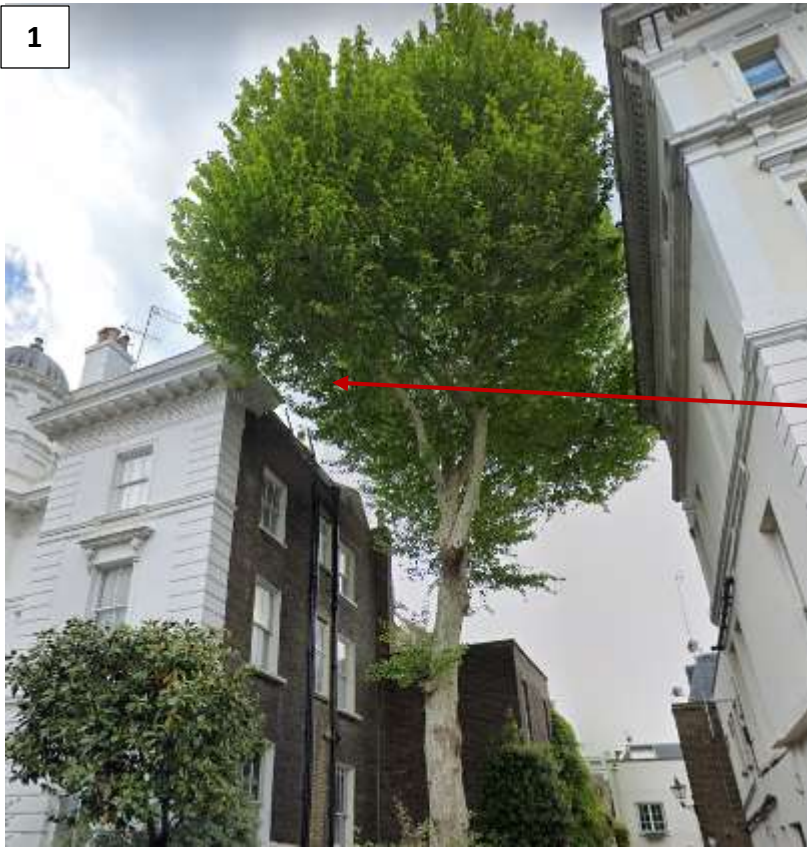
1

T1: Close proximity to adjacent dwellings May 2019.

The mitigation in place for the structural concern of T1 has left the canopy at a level that will continually cause neighbourly conflict (image 1&2). Unless this specimen is re-pollarded every year it will continue to grow into adjacent building at window level. Re-pollarding every year would be effectively managing its decline and remove the retention value of this specimen.

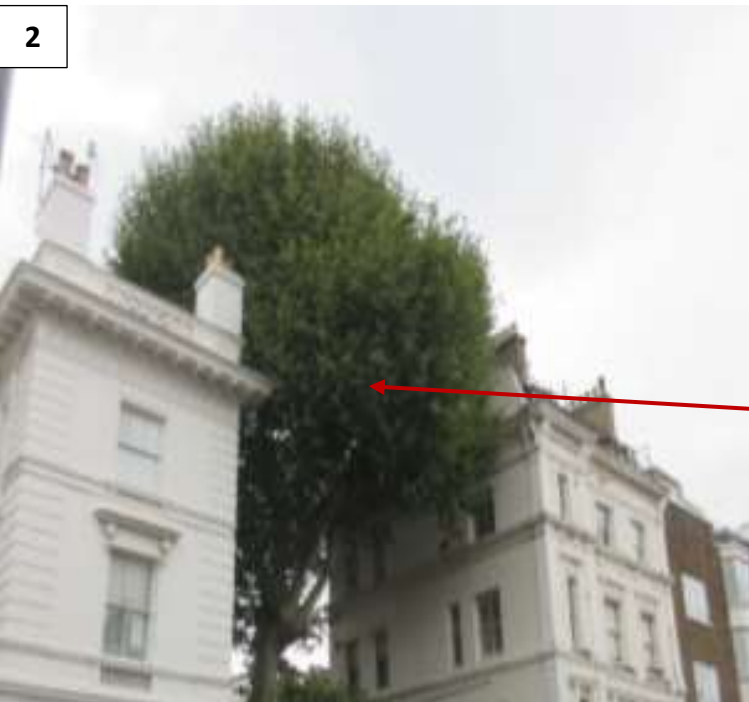
2

T1: Impact upon adjacent dwellings October 2019.

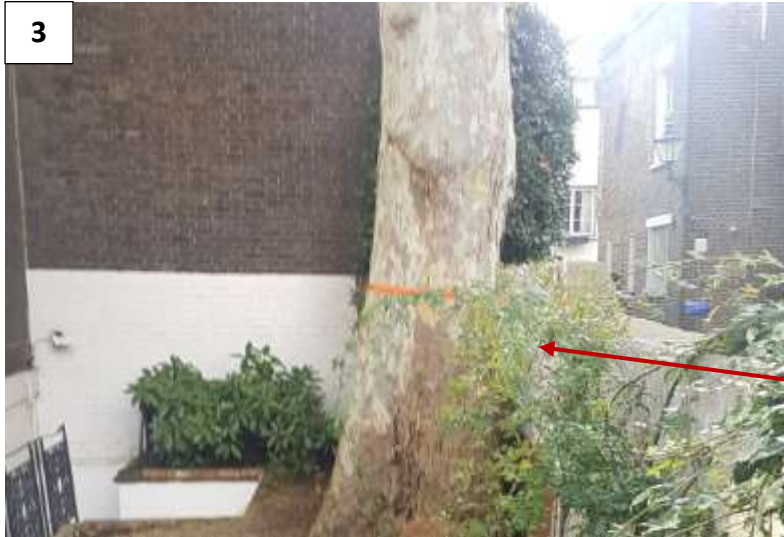
3

T1: Stem expansion approximately 8cm from retaining wall.

Any building works to integrate the cohabitation between T1 and the retaining wall would be temporary. A lintel cannot be constructed over the root expanse as that would put the root expansion into the public carriageway at 0.5m above highway level, stem expansion would also continue to displace the structure. An open wall construction is not an option in this instance as the tree is already being managed for decline.

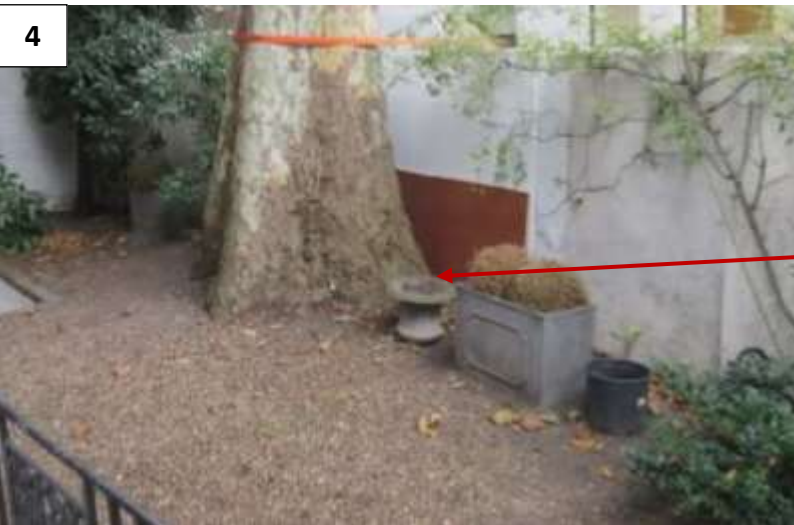
4

T1: Root-crown directly affecting structure.

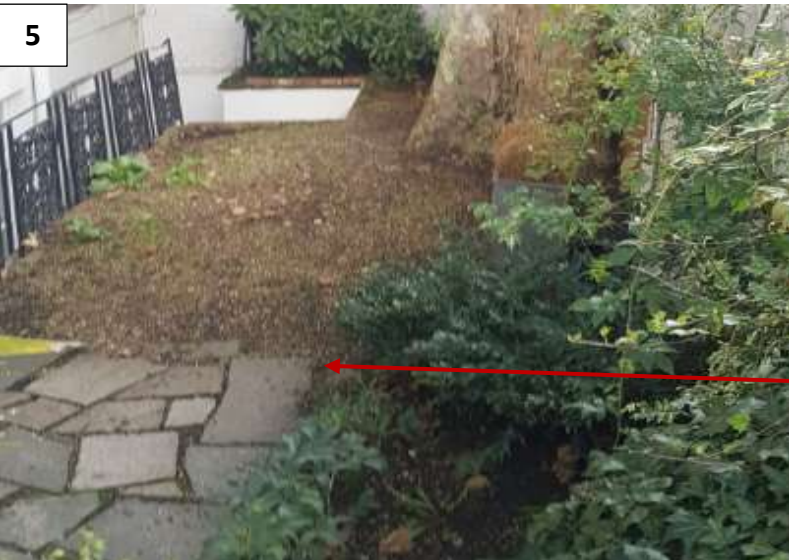
5

T1: Limited rooting volume.

The rooting volume potential for T1 will continually bring rhizome expansion into direct conflict with the retaining wall, partitioning Queens Gate Mews and the rear of 1 Kensington Gate. Any root removal works would limit the structural stability of an already compromised structure and should not be considered as a mitigation.

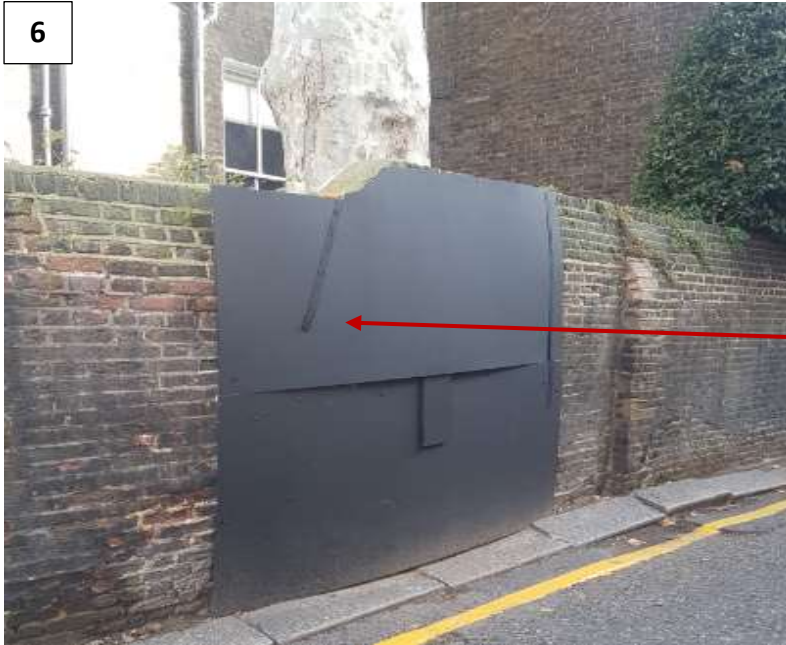
6

T1: Stem expansion and root proliferation displacing wall.

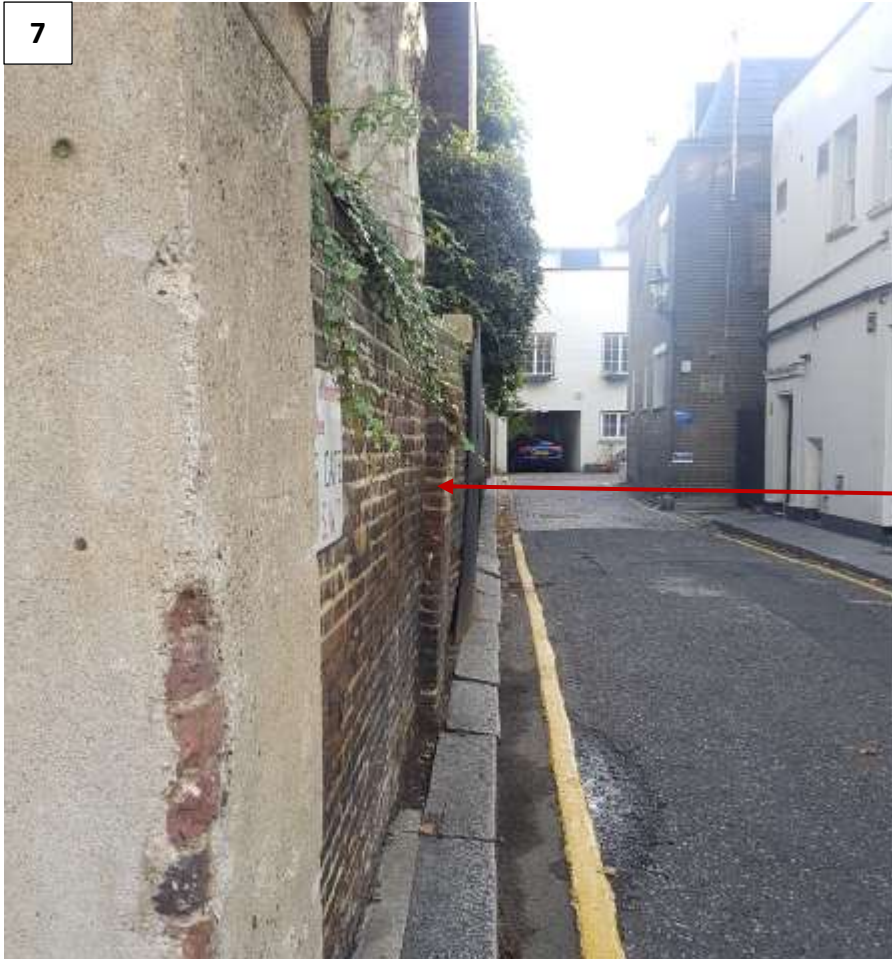
7

T1: Structural displacement as a result of direct root and stem expansion.

In this instance Evertree agrees with the analysis of MMA Report Ref: 19090. T1 requires removal to mitigate the stated factors within the engineering report as well as the arboricultural reasons stated within this report. However, to offset loss, a replacement strategy should be in place that takes into account all the restrictive factors of the site. This will give a longevity to the prospective replacement and *should* be a condition discharged by the LPA.

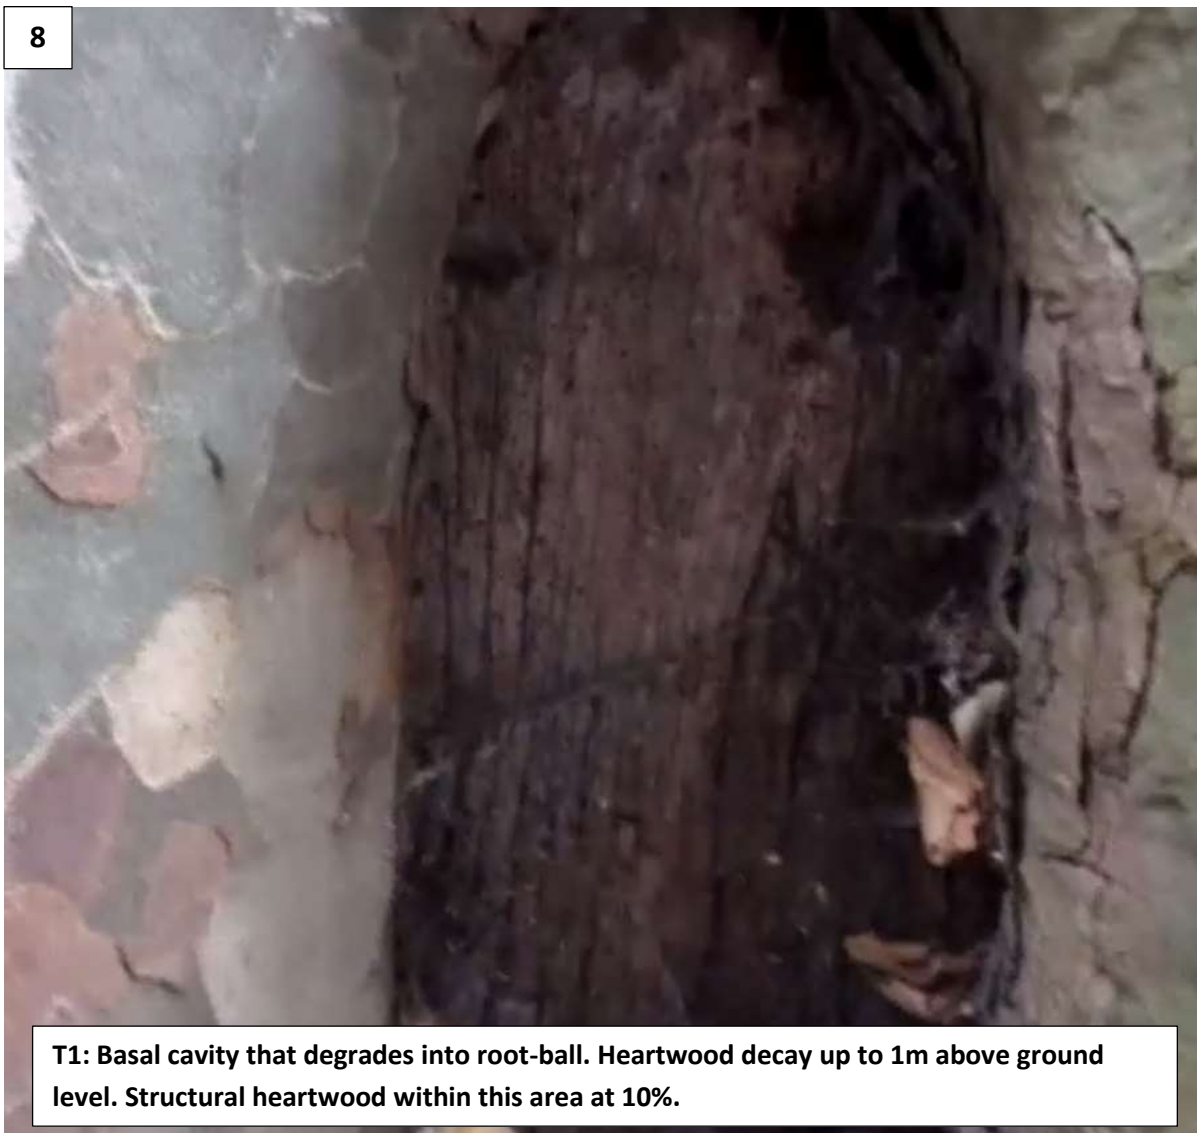
8

- 5.1 Root proliferation and stem expansion has directly affected the retaining wall, partitioning Queens Gate Mews and the rear of 1 Kensington Gate.
- 5.2 The displacement of the Queens Gate Mews wall has led to a dangerous structure that has a temporary retention in place.
- 5.3 T1 appear to have been managed as a result of lower stem decay. This has been implemented in the form of a continual pollarding and re-pollarding regime.
- 5.4 T1 structural mitigation in the form of re-pollarding has led to a crown spread that directly interacts with adjacent, neighbouring structure.
- 5.5 T1 has a very low rooting volume and therefore will continue to expand within the available substrate.
- 5.6 T1 is within the NHBC 4.2 area of theoretical influence (3.7).
- 5.7 No wildlife or nesting birds were identified during the survey of T1 (3.4. 3.5, 3.6)

5.8 Any recommended tree works need to be taken out in accordance with BS:3998 (3.3)
