# Arboricultural Survey, Appraisal and Recommendations

10/06/2018

**Report Reference: QUEENDR001**

**Longacre Professional Arboricultural Consultancy**

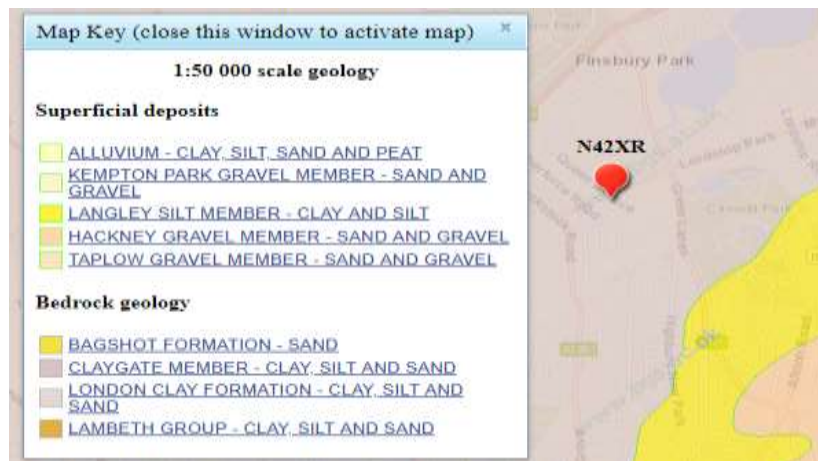
#### Topography

Status Code:	Full
Age range:	Ypresian Age (GY) – Ypresian Age (GY)
Lithological Description:	The Claygate Member comprises dark grey clays with sand laminae, passing up into thin alternations of clays, silts and fine-grained sand, with beds of bioturbated silt. Ferruginous concretions and septarian nodules occur in places. Fossils from the Claygate Member at Willesden Green are recorded by Wrigley (1921).
Definition of Lower Boundary:	The Claygate Member is distinguished from the underlying Sheppey Member by the laminated character and relative abundance of sand in the Claygate Member. The boundary is drawn at the base of the lowest sand bed, conformable on silty clay with common sandy clayey silt interbeds. In practical terms, it is taken at the 'lowest sandy horizon mappable in the field' (Lake et al., 1986). In London, and further to the west, sand beds appear lower in the sequence and here the base of the Claygate Member is based on other criteria including grain size and glauconite content (Ellison et al., 2004).
