**Longacre Professional Arboricultural Consultancy**

Arboricultural Survey, Recommendations and Cyclical Management Plan

08/09/2018

Report Reference: LYE001

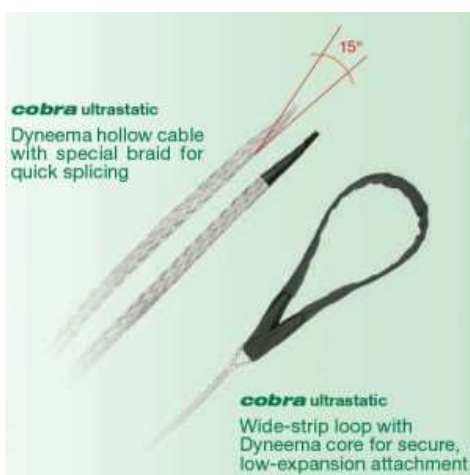
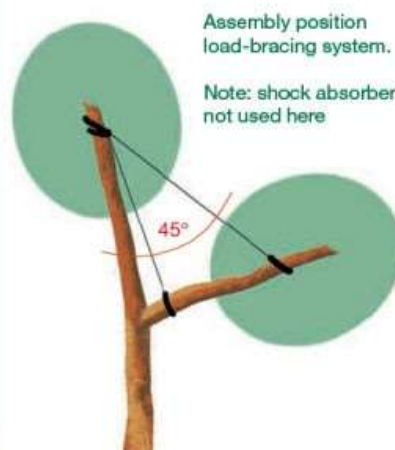
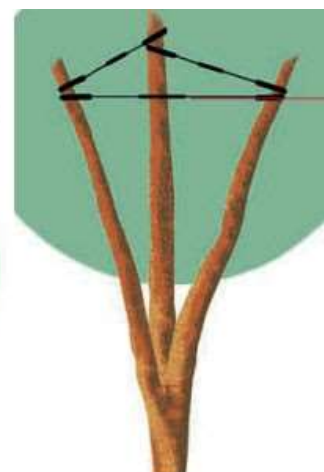
The fork of this Oak has a weakness that can be seen running from the crown break vertically into the main stem.

Supporting the twin leaders by bracing them against each other will help mitigate potential failure onto the driveway.
