Longacre Professional Arboricultural Consultancy

Arboricultural Survey, Recommendations and Cyclical Management Plan

08/09/2018

Report Reference: LYE001

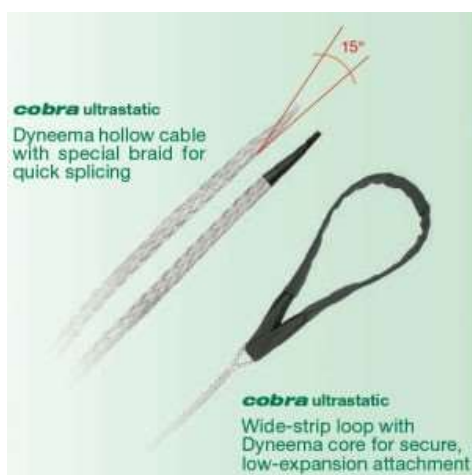
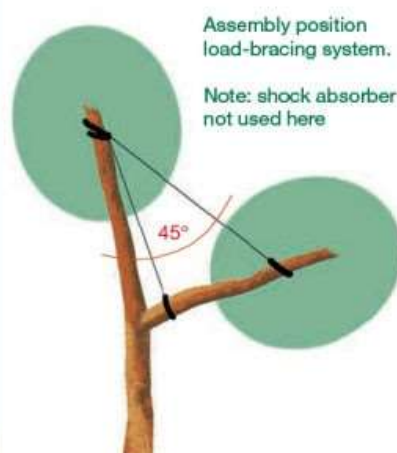
The fork of this Oak has a weakness that can be seen running from the crown break vertically into the main stem.

Supporting the twin leaders by bracing them against each other will help mitigate potential failure onto the driveway.
