Arboricultural Appraisal

Hatfield Broad Oak Parish

Report Reference: TS00123_HATBR_5888

Date of inspection: 22/04/2024

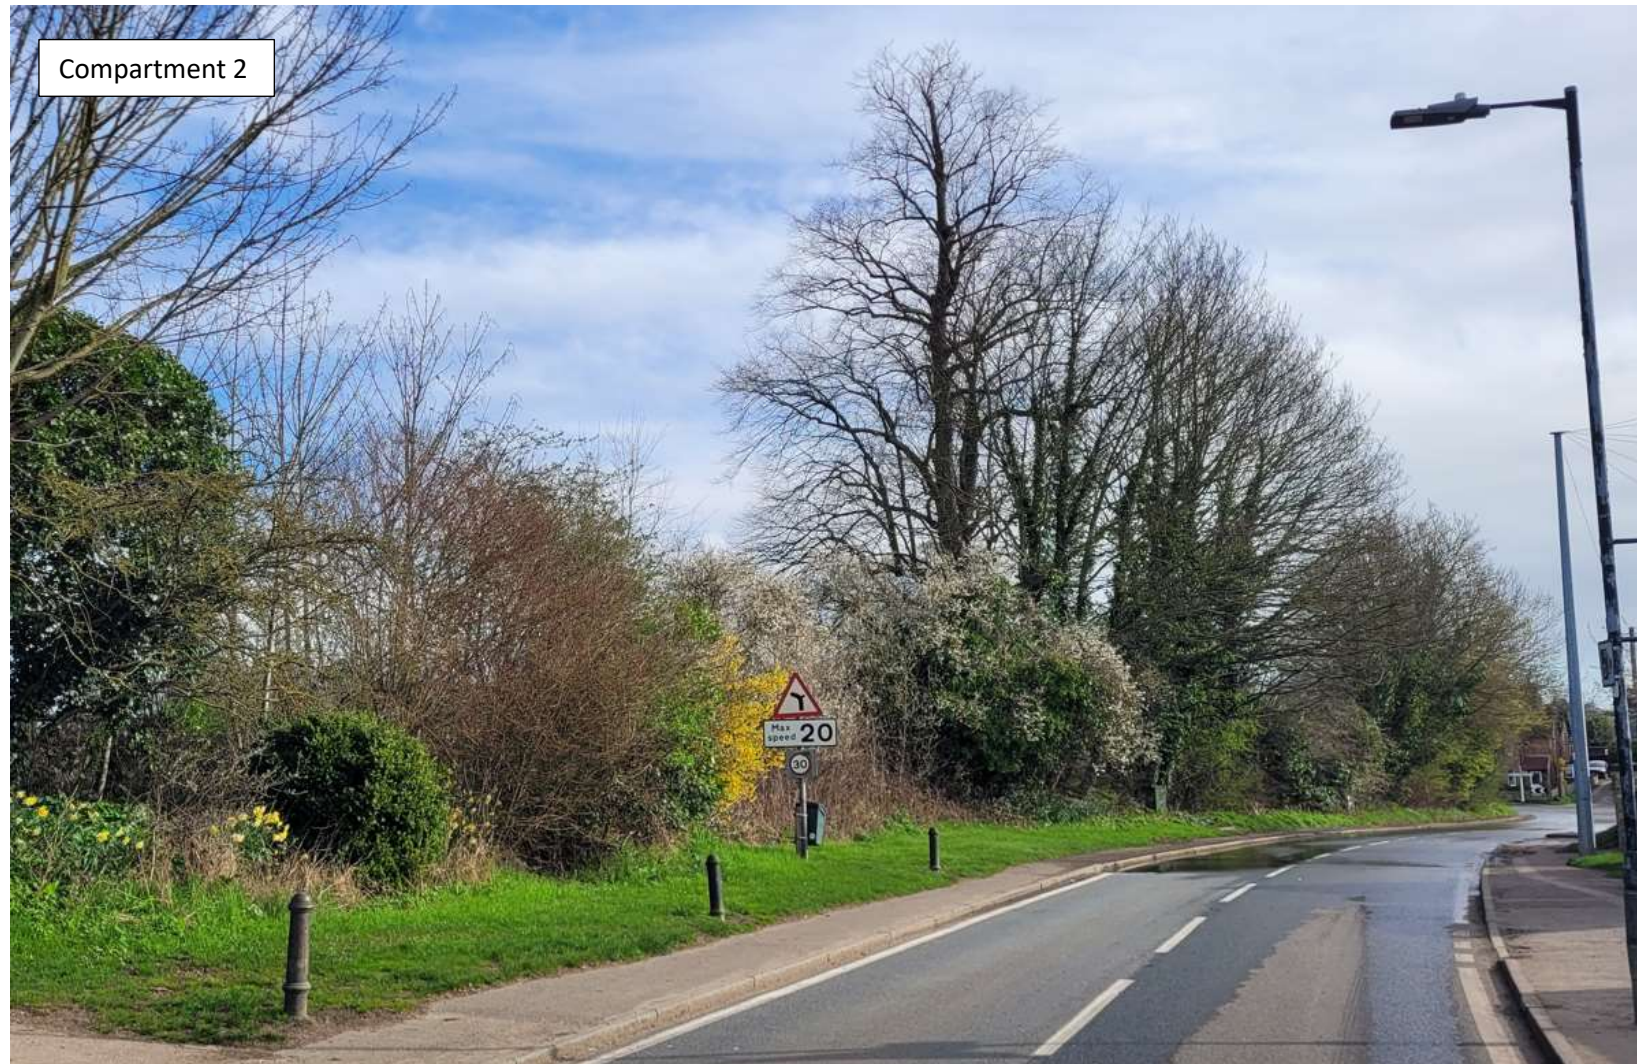
3505	14	Sycamore	C2 Opp Dukes Orchard	300	17	9	Semi Mat	Good	Good	Multi stem Good	Good	Good	Good	N/A	Crown lift 5m	Medium	3
3506	15	Thorn	C2 Opp Dukes head car park	200	10	6	Mature	Good	Good	Multi stem Good	Good	Good	Good	N/A	Crown lift 5m	Medium	3
3507	16	Sycamore	C2 Opp pub	350	14	9	Mature	Good	Good	Multi stem Good	Good	Good	Good	N/A	Crown lift 5m	Medium	3
3508	17	Ash	C2 Opp pub	350	16	9	Mature	Good	Good	Forked stem - Good	Good	Good	Good	N/A	Crown lift 5m, 50% cut back of road overhang	Medium	3
COMPARTMENT 2 OVERVIEW	Sooty bark present within stock this will require monitoring of the Sycamore on an annual basis to gauge the progression. Low growth over road will be a restriction to high sided vehicles sometime within the next 12 month. Flail works apparent but not to extra heavy vehicle height.

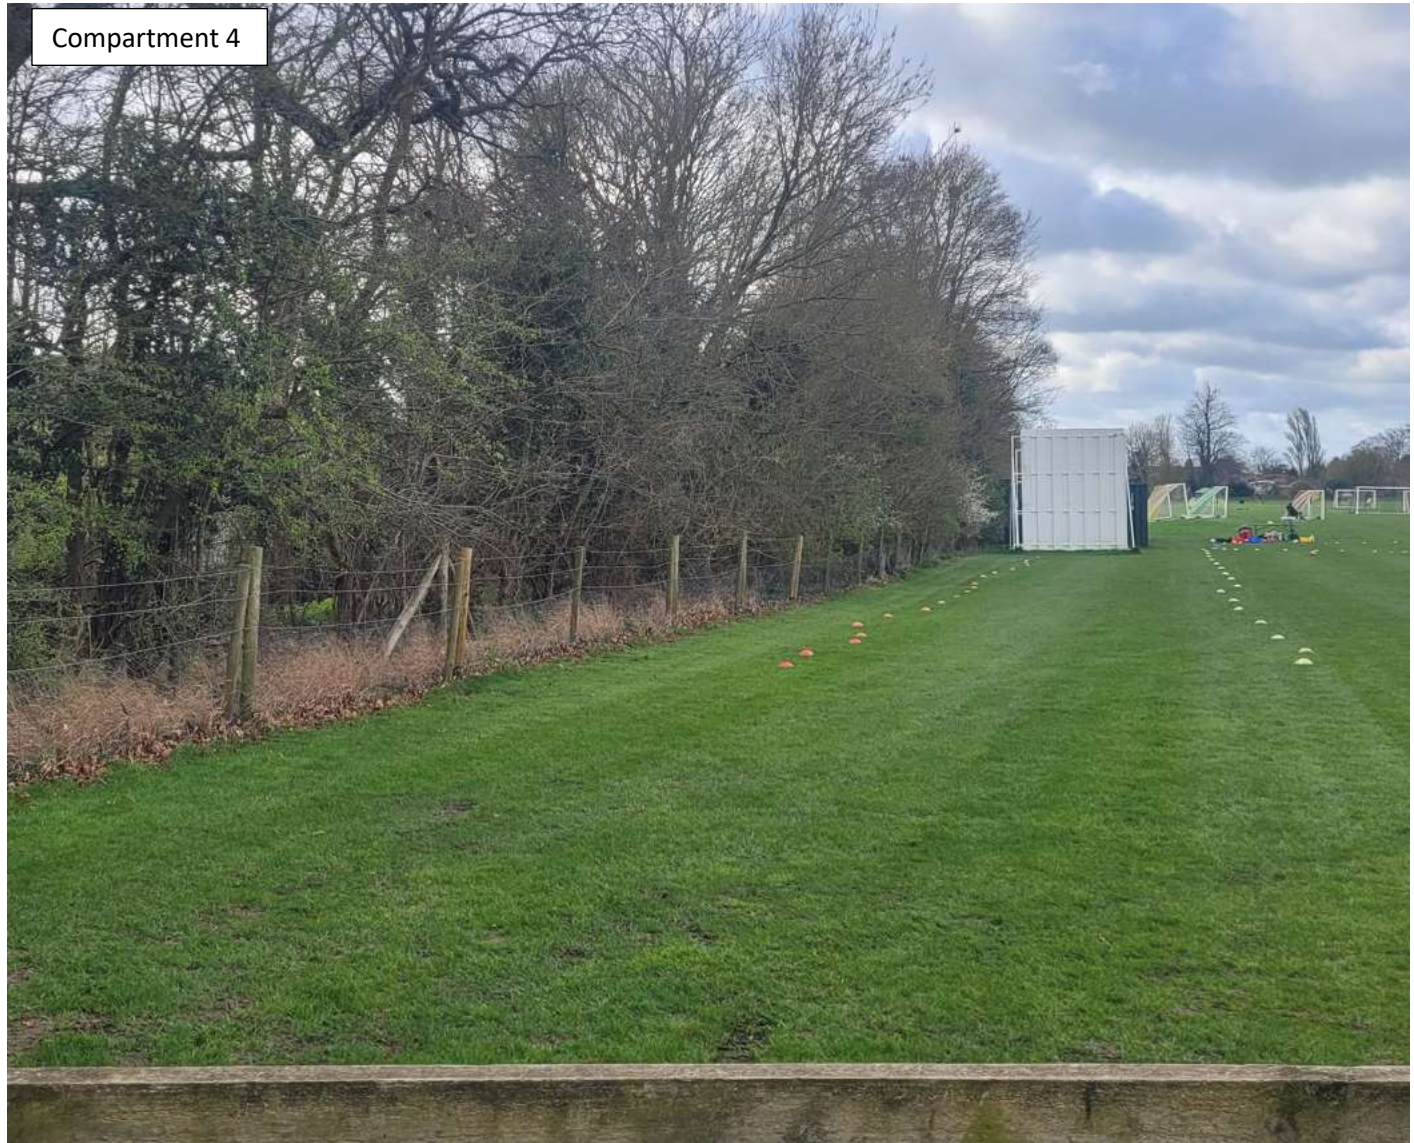
Compartment 4

Tag ref	Map ref	Species	Location	DBH (mm)	Height (m)	Radial crown spread (m)	Age	Crown	Crown break	Stem	Root crown	Rooting area	Overall Condition	Comments	Recommendation(s)	Risk	Priority	
3554	30	Elm x5	C4 Football pitches, road adjacent	100	7	3	young tree	Good	Good	Good	Good	Good	Good	dead	tag on post	Fell to ground level		3
3555	31	Ash	C4 Football pitches, road adjacent within ecological area	400	6	2	Mature	Poor	Poor	Poor	Poor	Good	Poor	<i>Prenniporia fraxinea (ffb)</i> – Tree well managed, reduced to prevent failure	N/A			
COMPARTMENT 4 OVERVIEW			No risk associated with area apart from pocket of dead elm adjacent to fence line. Ecological areas are closed off to public.

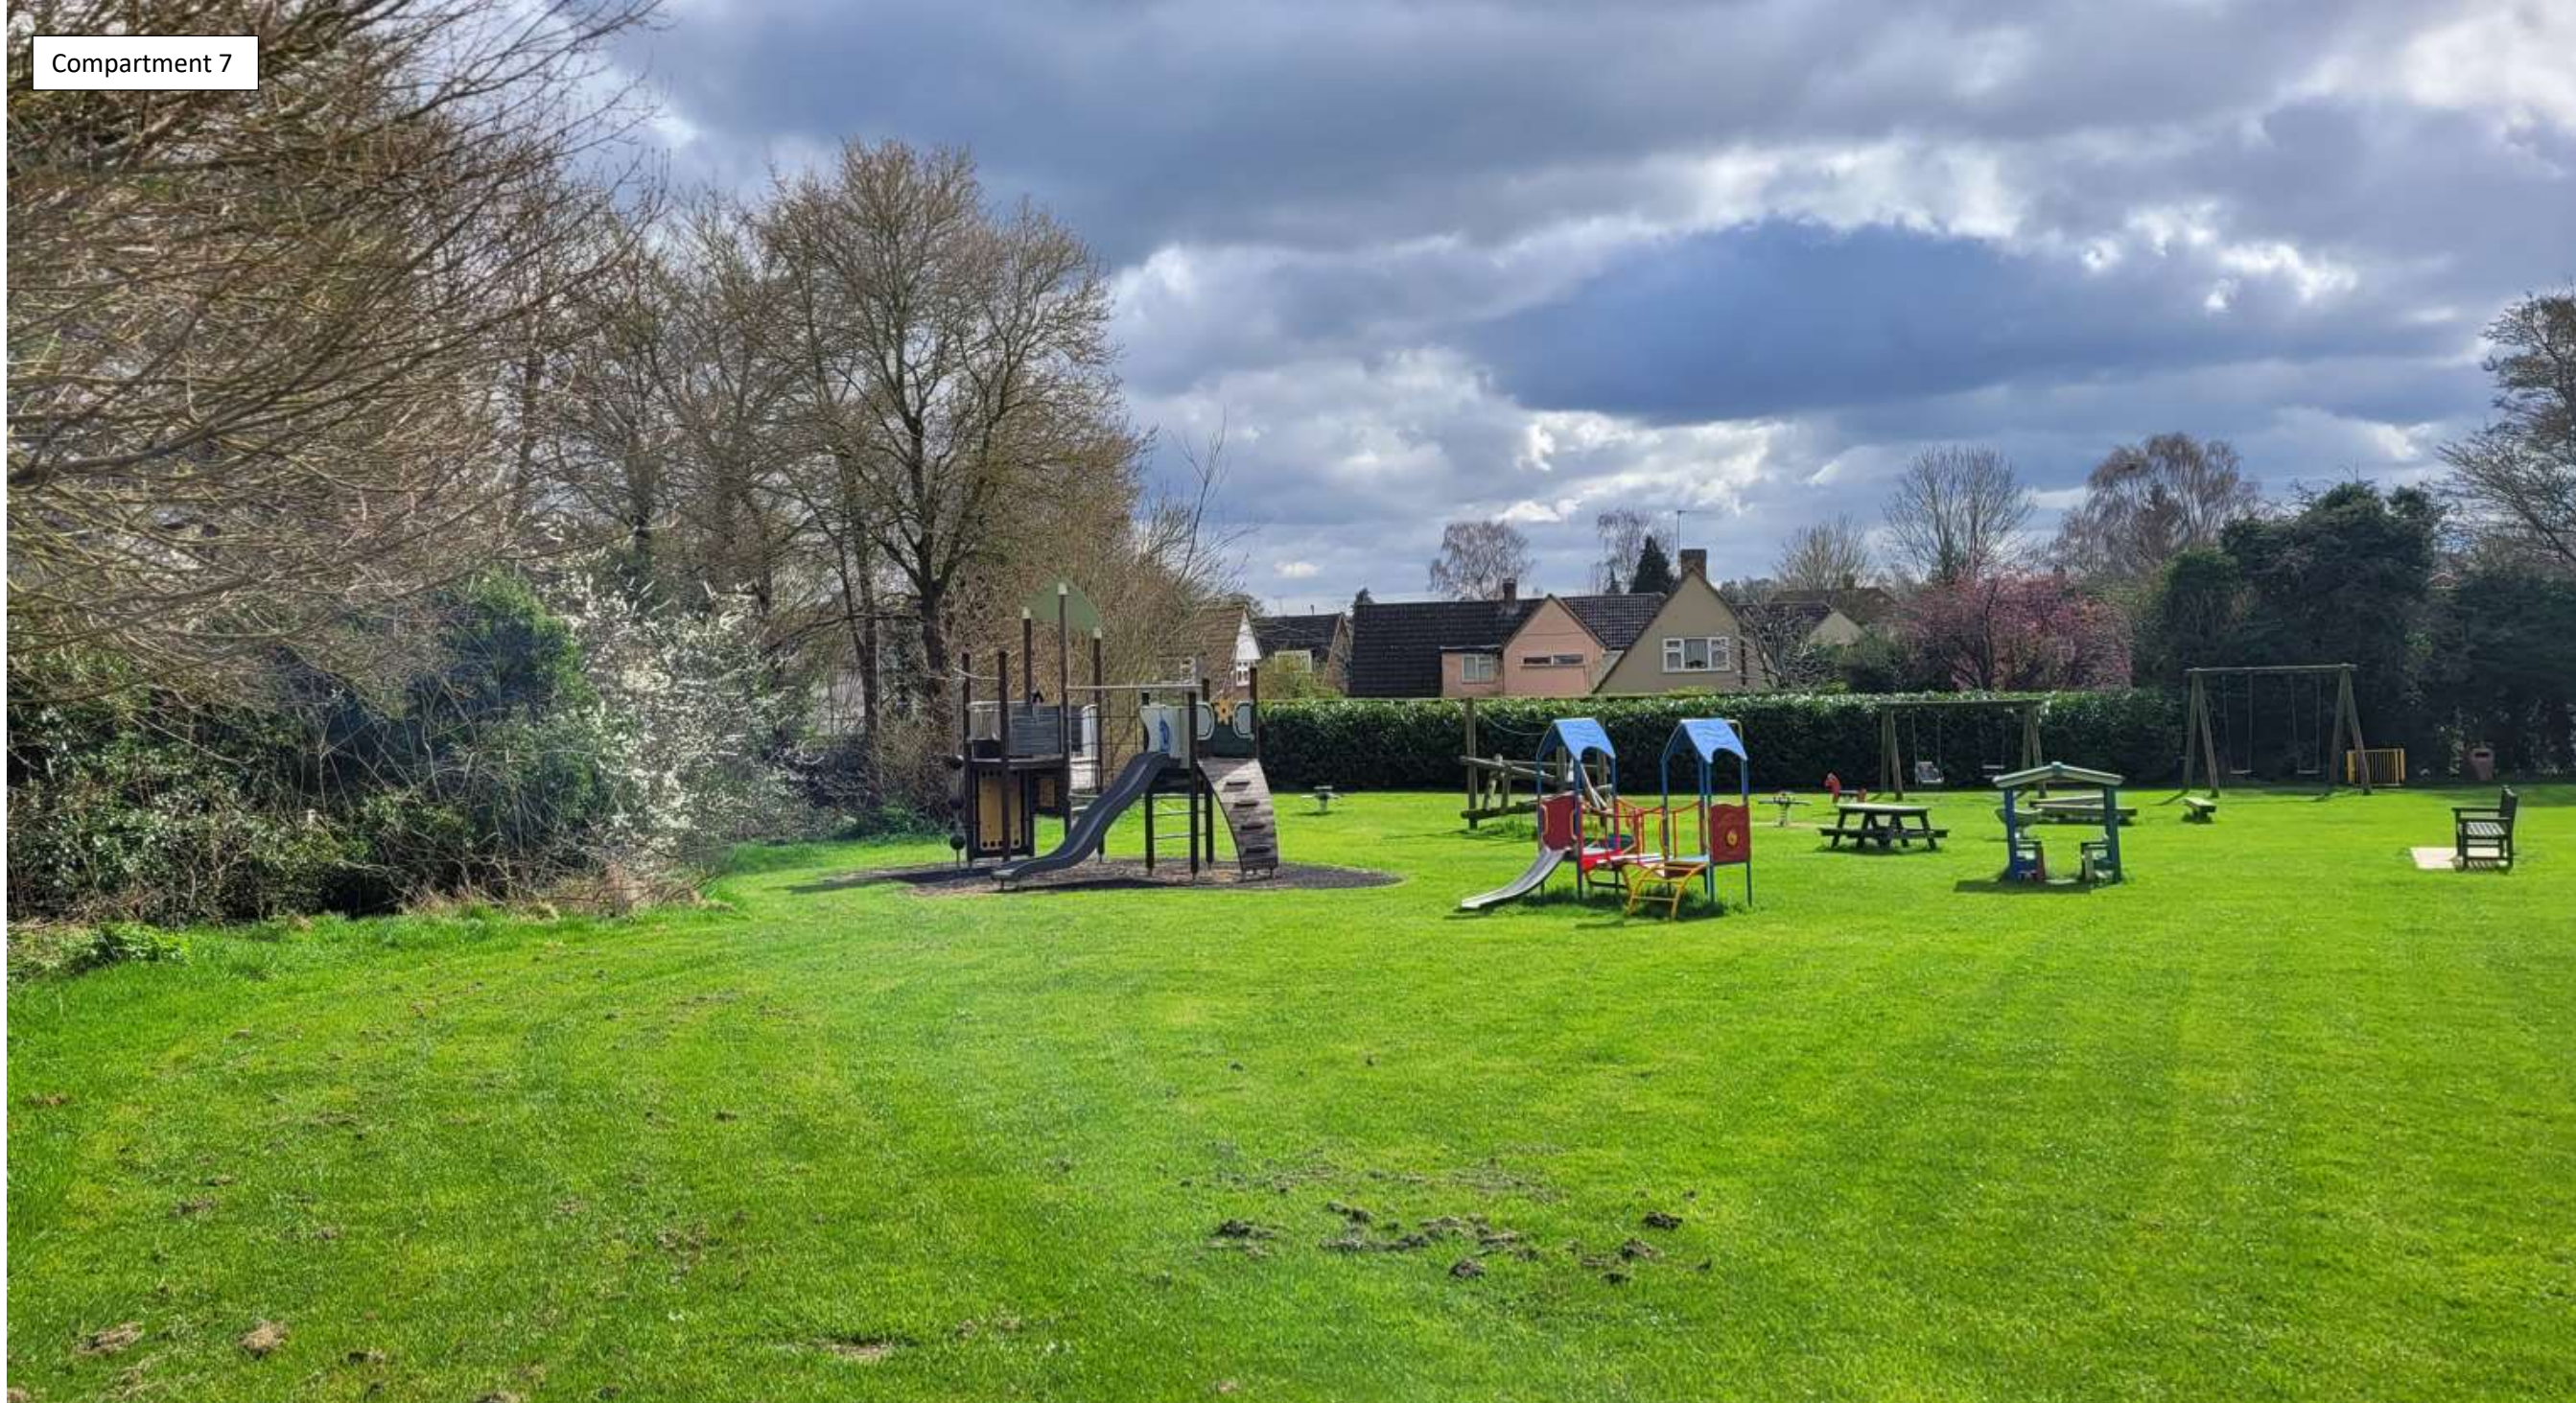
MAP/ Tag ref	Species	Location	DBH (mm)	Height (m)	Radial crown spread (m)	Age	Crown	Crown break	Stem	Root crown	Rooting area	Overall Condition	Comments	Recommendation(s)		
COMPARTMENT 7 OVERVIEW	No risk associated with land due to tree condition. There are notable issues with the lapsed hedge and shrub adjacent to the waterway, but this is outside of the area of occupation, not considered an arboricultural feature, and away from the play zone. It would be worth considering restricting access to the waterway.

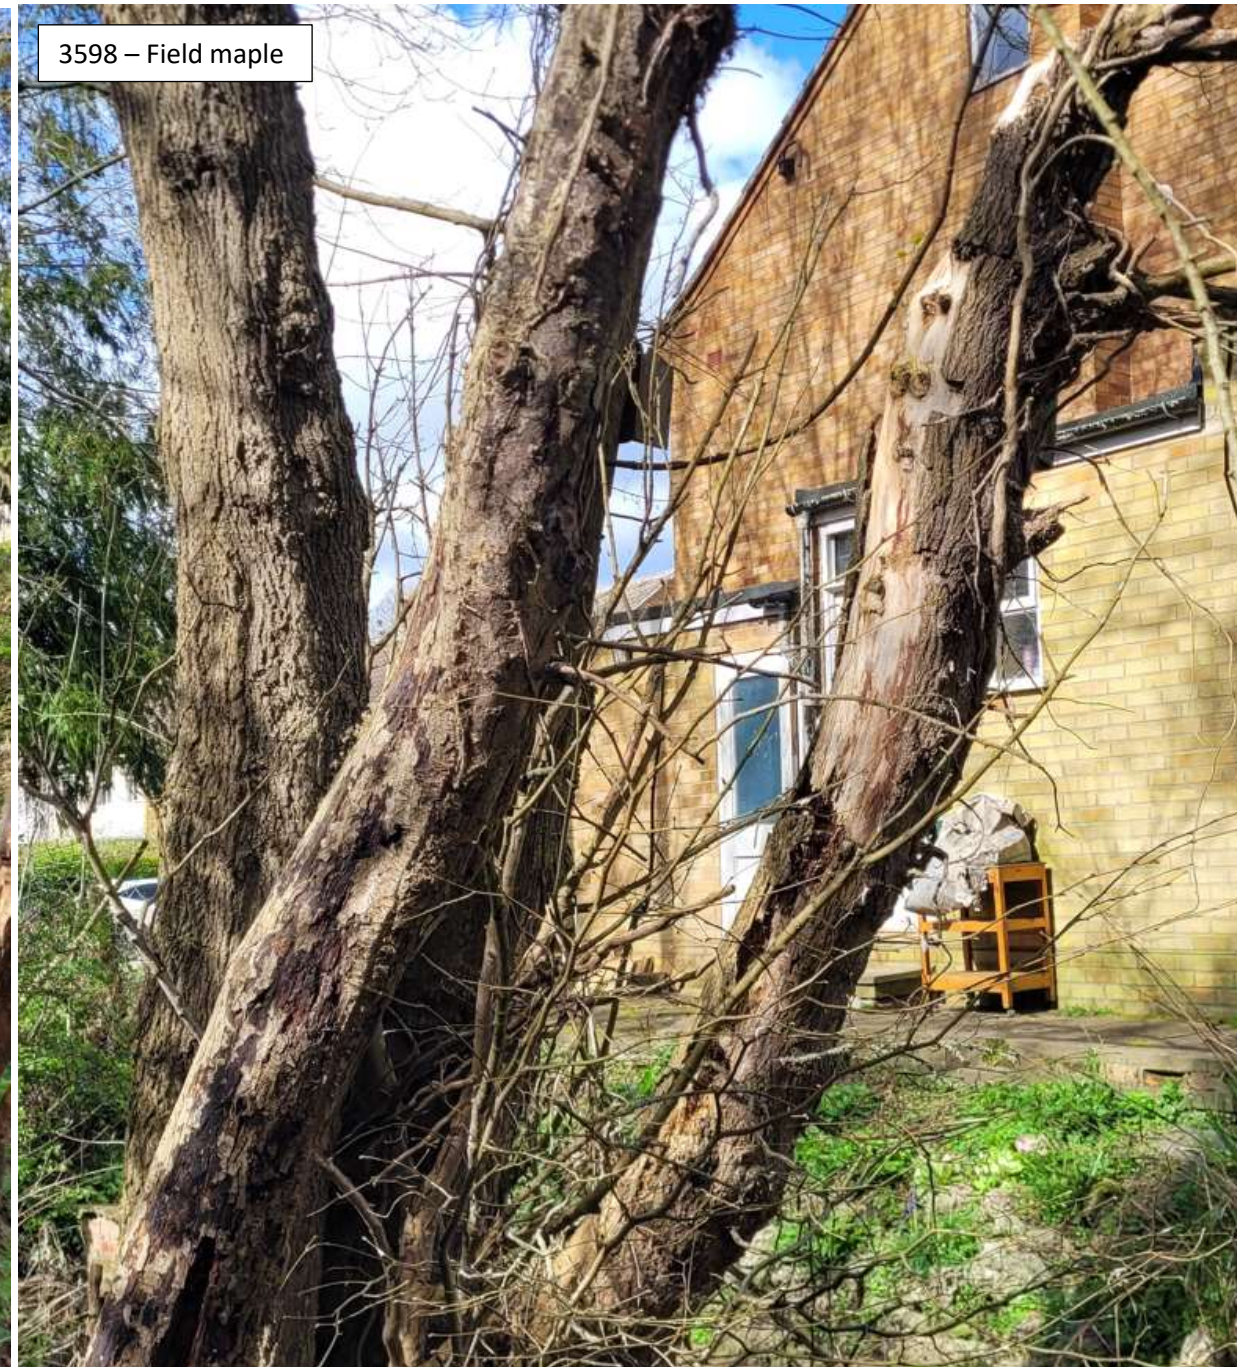
3598 – Field maple

Tag ref	Map ref	Species	Location	DBH (mm)	Height (m)	Radial crown spread (m)	Age	Crown	Crown break	Stem	Root crown	Rooting area	Overall Condition	Comments	Recommendation(s)	Risk	Priority
3598	42	Maple	G8 adjacent to no.12	100	8	8		Poor	Poor	twin stem	Poor	Poor	Poor	Leaning	Fell		2
3599	43	Hawthorn	G8 Water course adjacent	110	6	3		x	x	x	x	x	Dead	Dead	Fell		2
3600	44	Hawthorn	G8 opposite no.4	140	5	4		x	x	x	x	x	Dead	Dead	Fell		2
3555	45	Ash	G8 adj Brook Hse	840	12	10		Good	Good	Good	Good	Good	Good	Proximity to property	Reduce to historic points of reduction		3
COMPARTMENT 8 OVERVIEW	Stressed and dead trees within the grass area adjacent to the waterway. Works is required to mitigate the risk of collapse which could cause injury to person or property or restrict access
